Cliffs of Moher Coastal Walk

Management Plan

Final Issue

April 2025

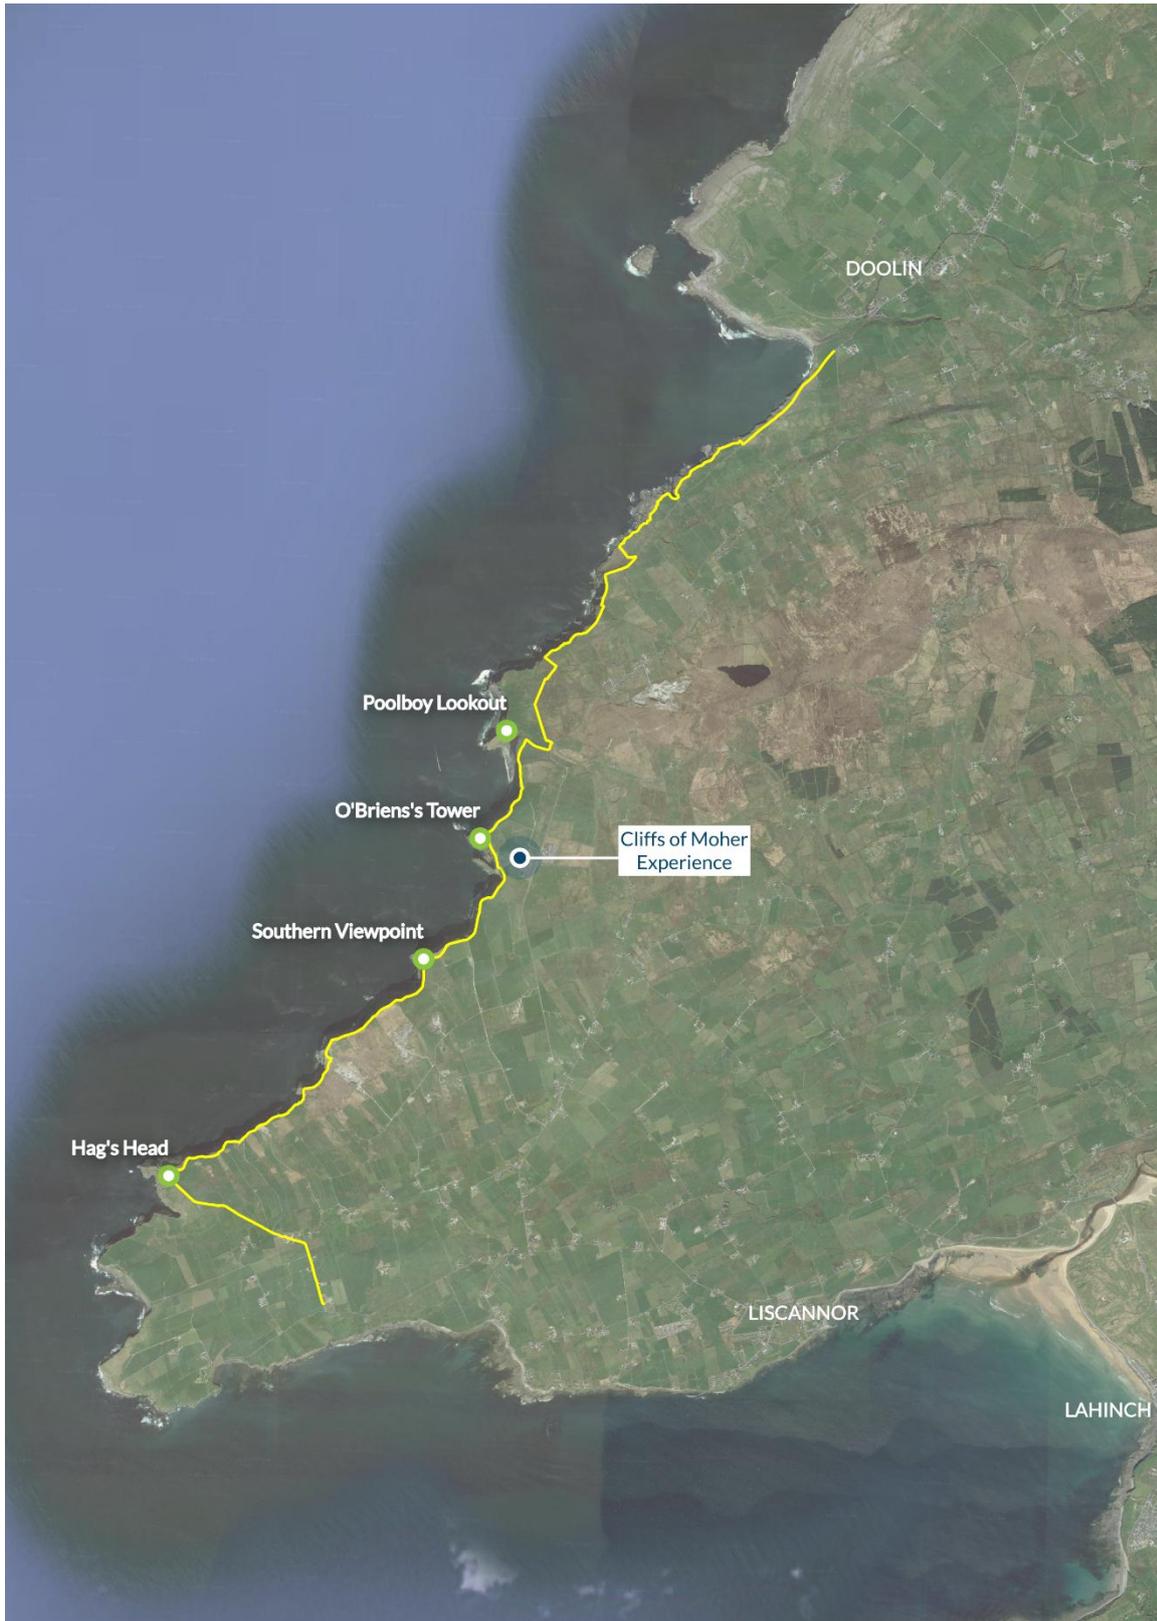
Figure 1-1: Cliffs of Moher Coastal Walk - Extents

The Cliffs of Moher Coastal Walk runs from Doolin in the north to south of Hags Head (see Figure 1-1). The official start and end points are somewhat poorly defined. In some documentation the trail continues to south Liscannor, while in other documentation it terminates at Moher GAA (the official trailhead at the southern end). The off-road section of the coastal walk runs for 11.43km.

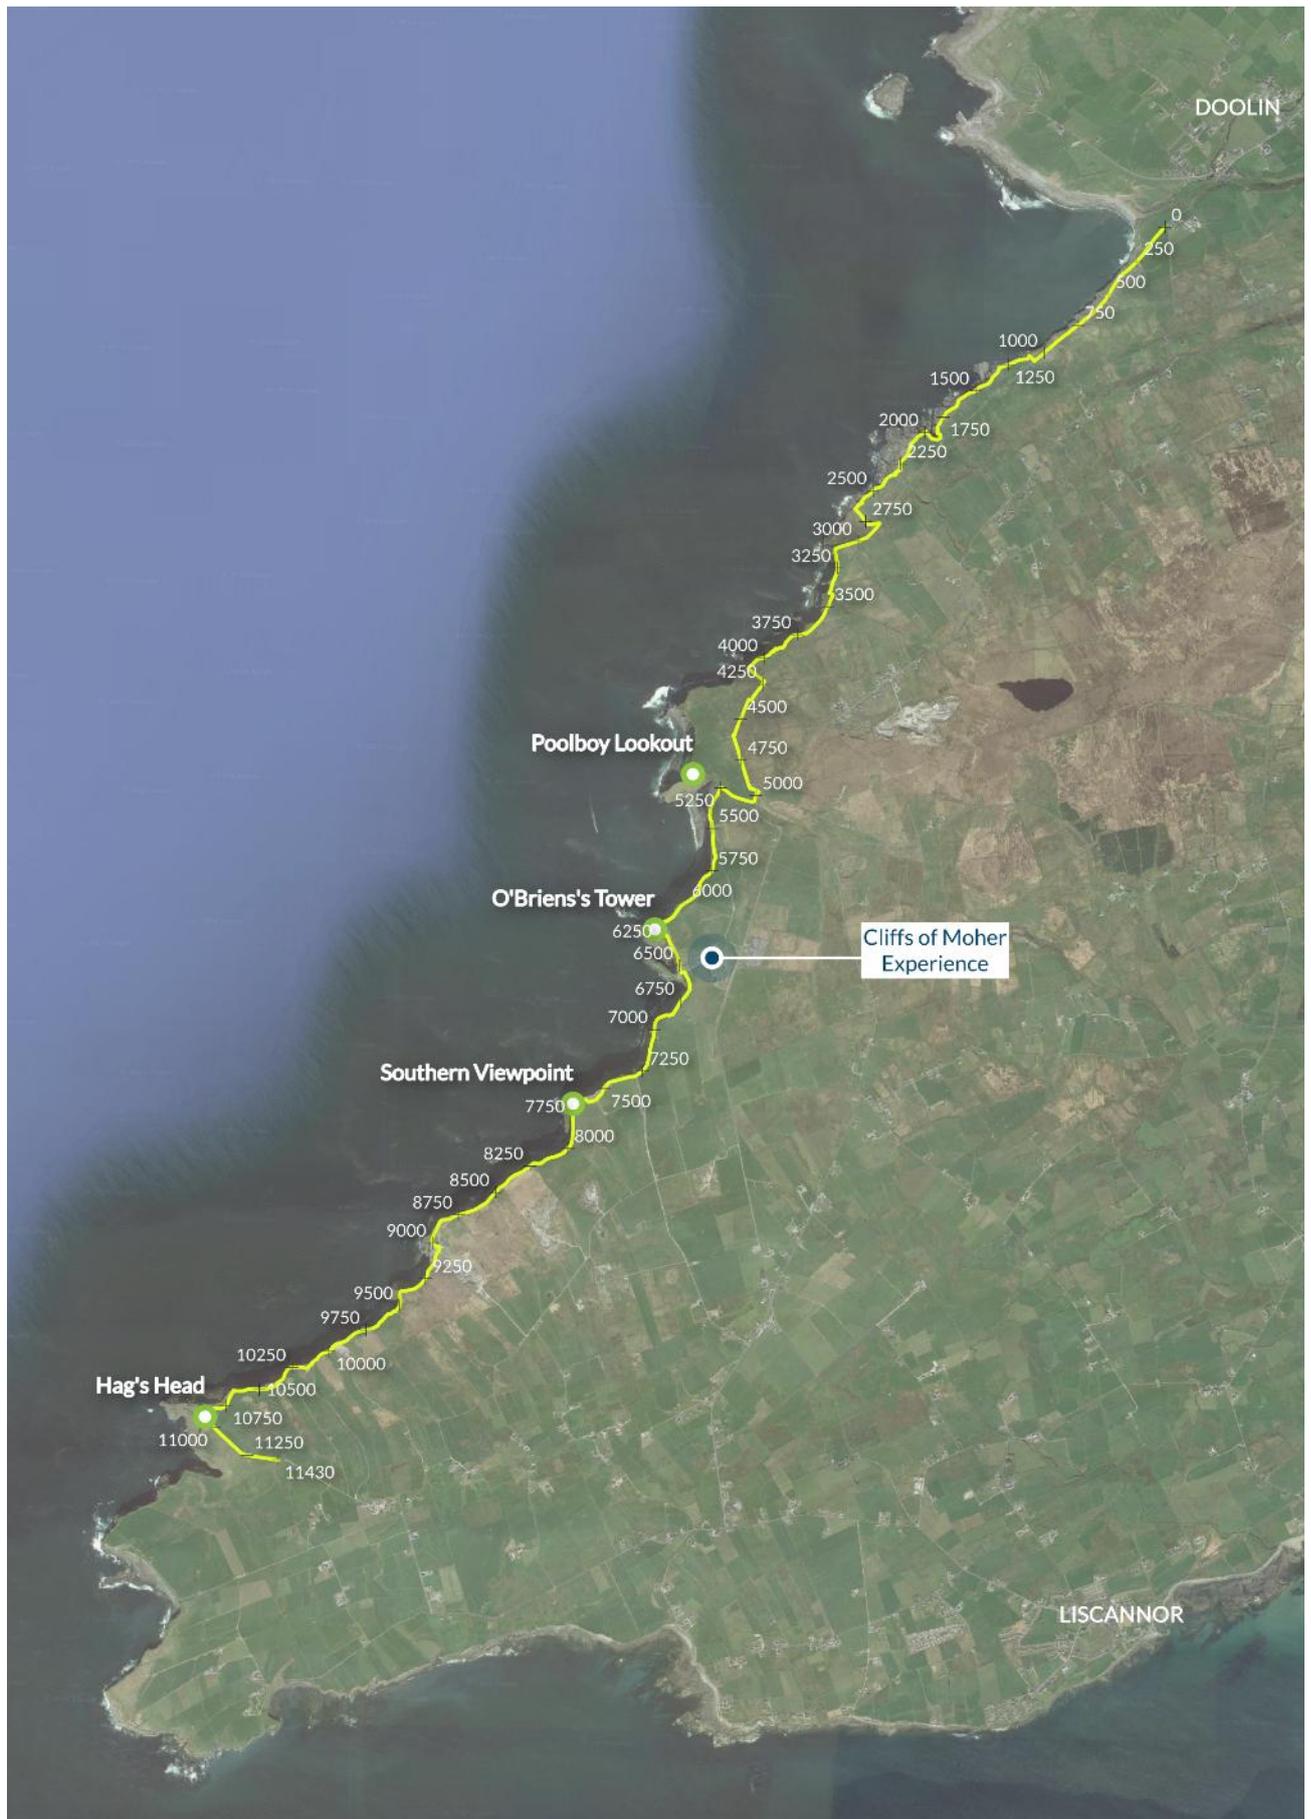
Figure 1-2: Chainages (Distance Markers) Used in this Report

Later in this report a discussion is presented about potential reroutes along sections of the Coastal Walk. For consistency, the chainages stated in that discussion are those associated with the existing Coastal Walk route not the new alignment.

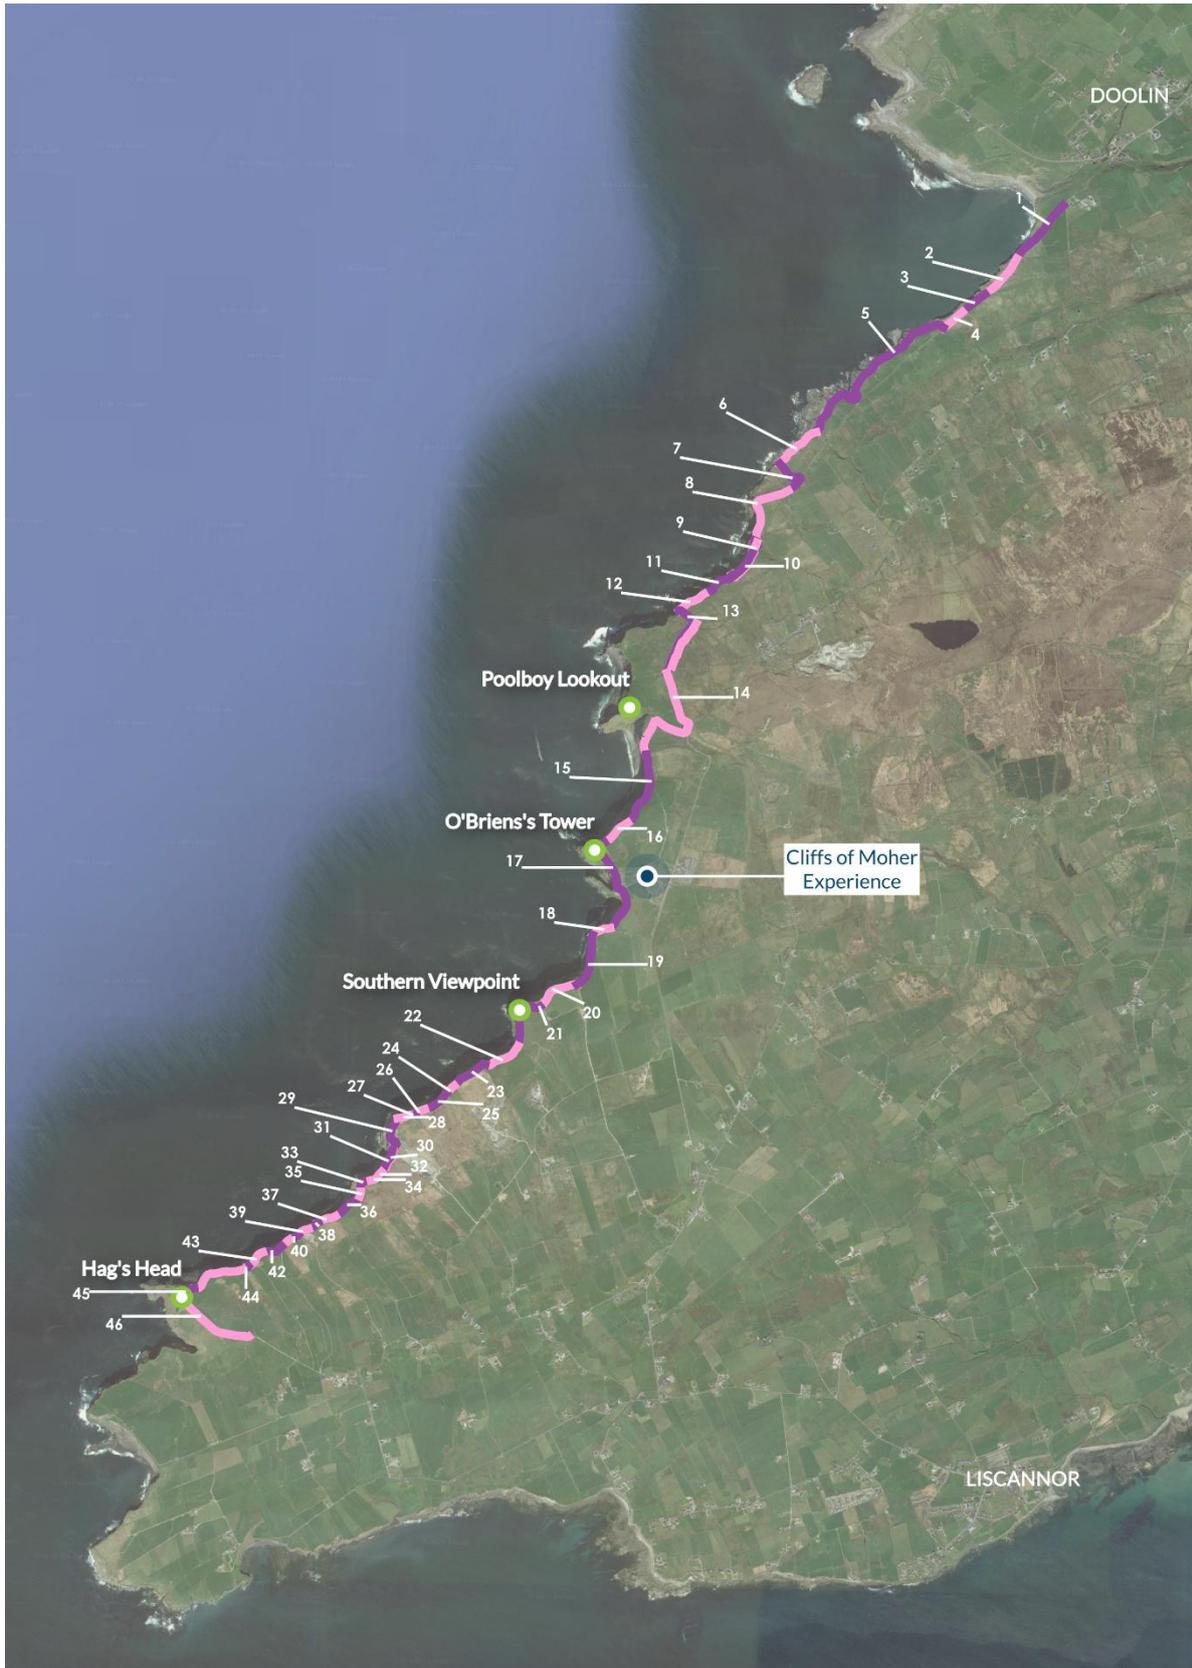
Figure 3-1: Ownership Folios

These 46 folios, comprising 36 separate landowners, are shown overleaf. This map clearly shows the significant variation in the lengths of trail on each folio (from 31m to 1265m).

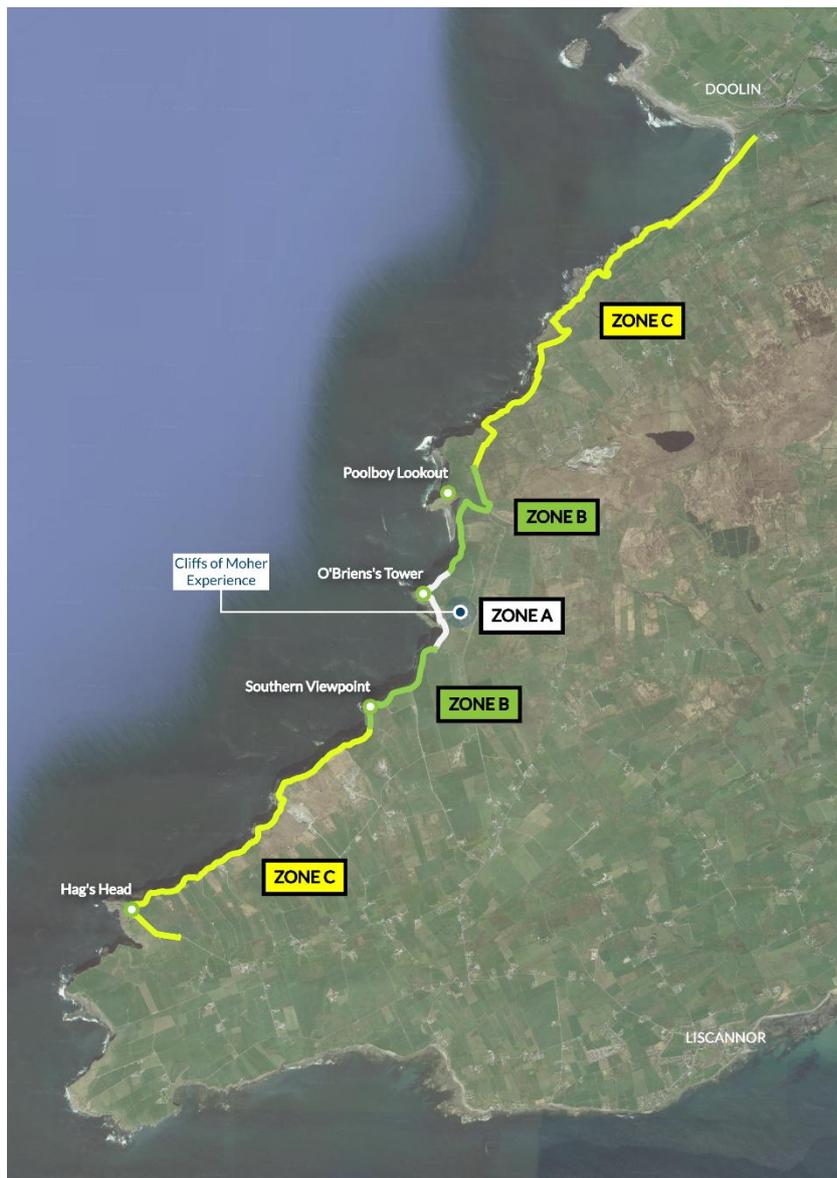
Figure 3-2: Current Trail Operation and Maintenance Zones

In essence, in terms of trail management, there are three zones:

- **Zone A.** Owned and operated by Clare County Council
- **Zone B.** Owned by 6 landowners, managed by Clare Local Development Company (CLDC), with investment and maintenance by Clare County Council
- **Zone C.** The remainder of the trail, owned by 28 landowners, operated by Clare Local Development Company (CLDC).

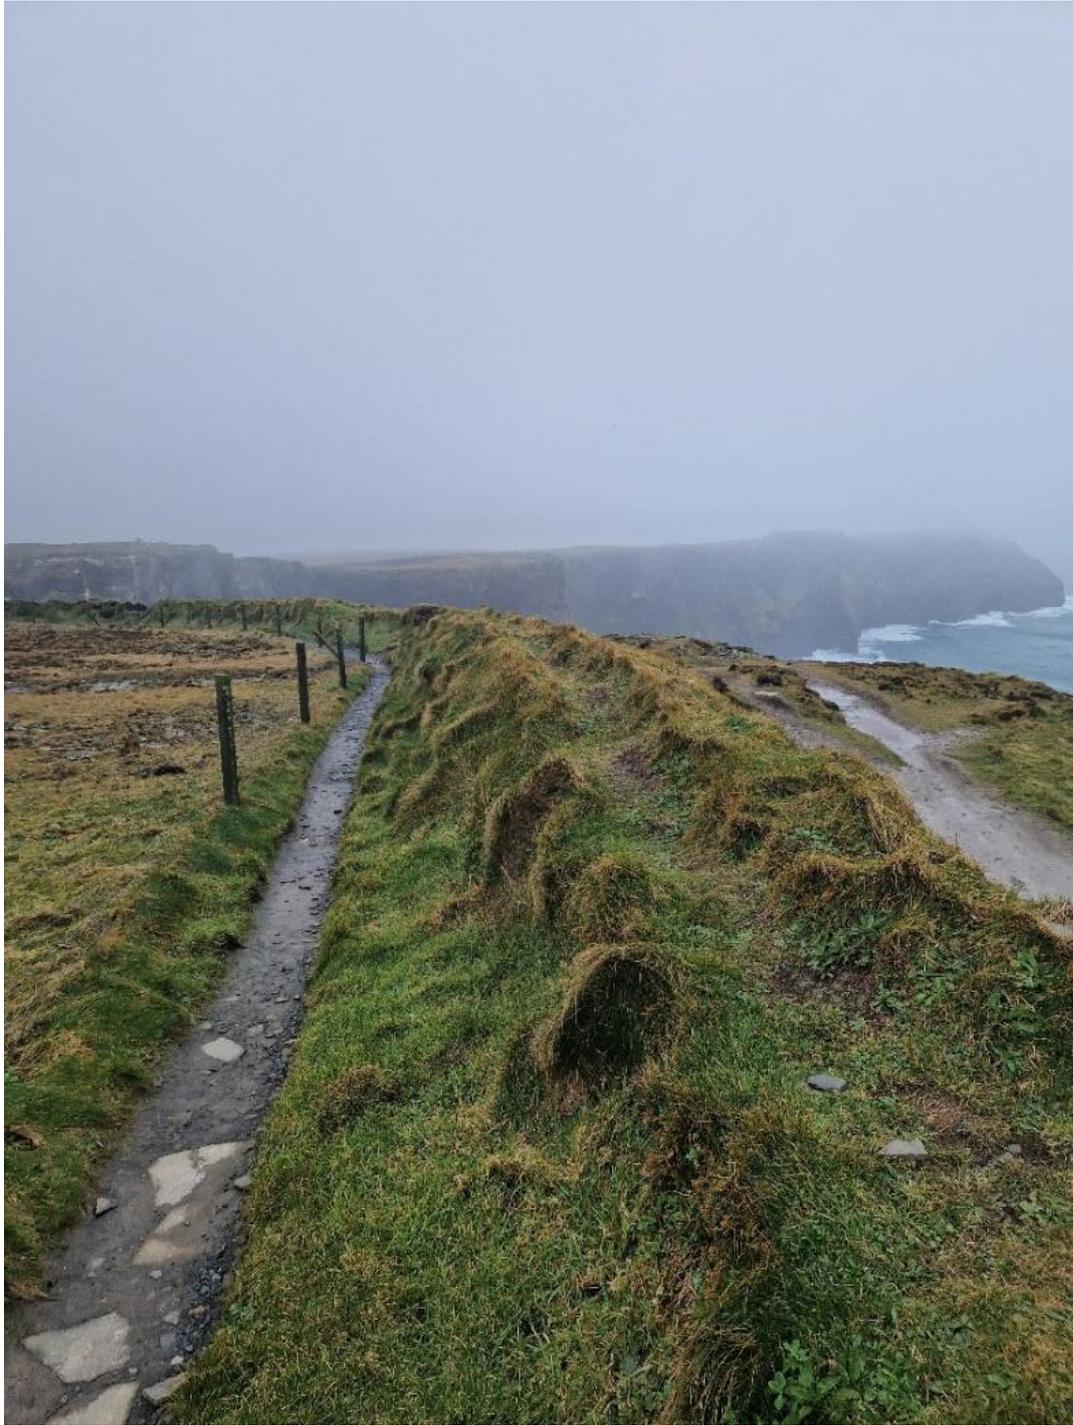
Figure 3-3: Example of Habitat Degradation

There are areas of worn ground / unofficial trails as a result of overcrowding, and this has caused extensive damage to existing biodiversity. These areas are characterised by bare ground/recolonising bare ground (ED1/2).

There are many examples of this degradation in the section of trail south of the Southern Viewpoint (see photo below). Damage to biodiversity is explored further in Section 6.5.

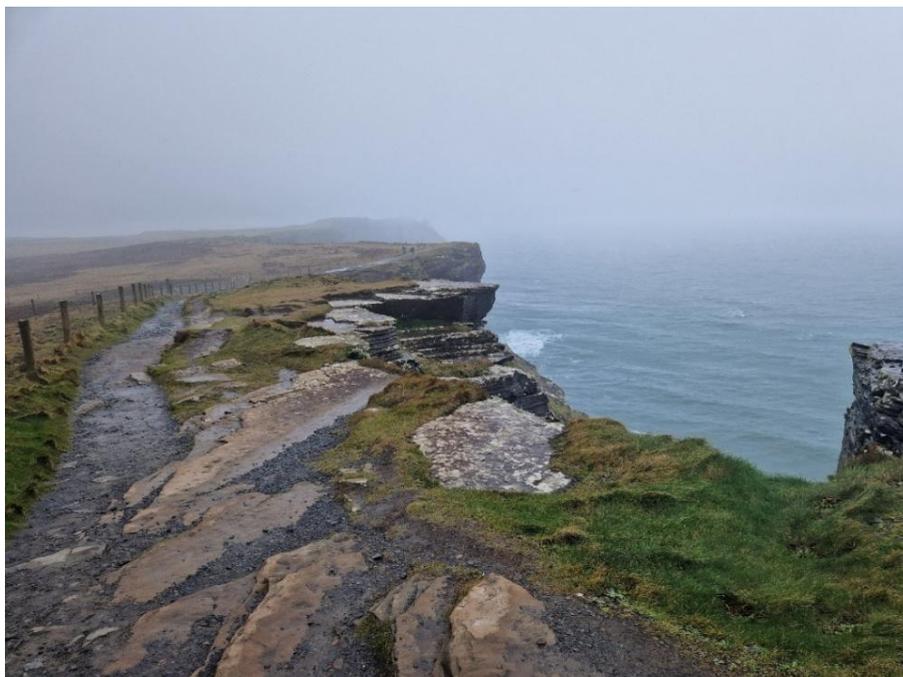
Figure 3-4: Trail Condition – Sample Unprotected Edge

High profile fatalities in recent years, in addition to the closure of parts of the trail as a result of the Sport Ireland audit, have highlighted the fact that sections of the trail are clearly unsafe.

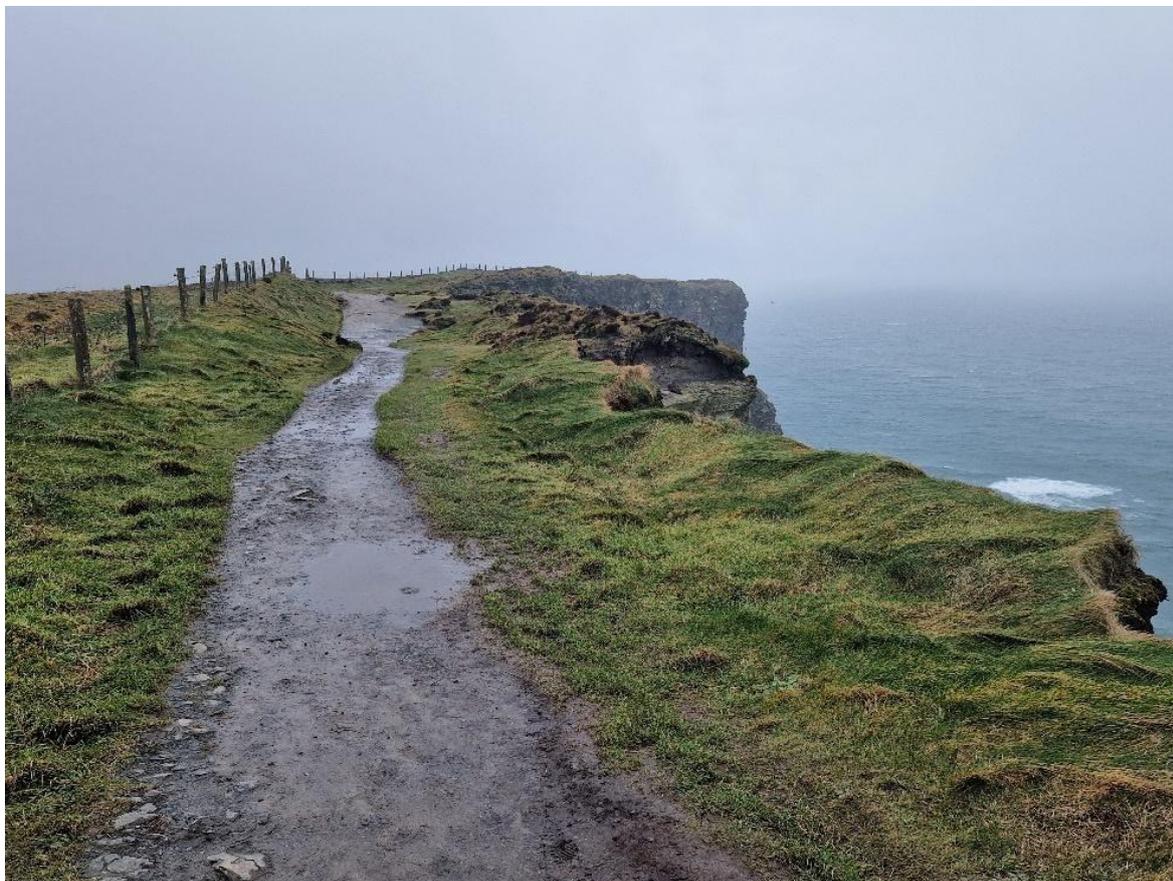
Figure 6-1: Example of Fenceline on Inland Side of Trail (Chainage 8400)

As mentioned earlier, compared to similar coastal walks, the Cliffs of Moher Coastal Walk is somewhat unusual in that users of the trail have to walk on the seaward side of an existing fenceline over long stretches. An example of this is shown below at Chainage 8400.

The purpose of the fence is therefore to prevent unauthorised access to the fields on the land side of the fence, rather than to protect the walker.

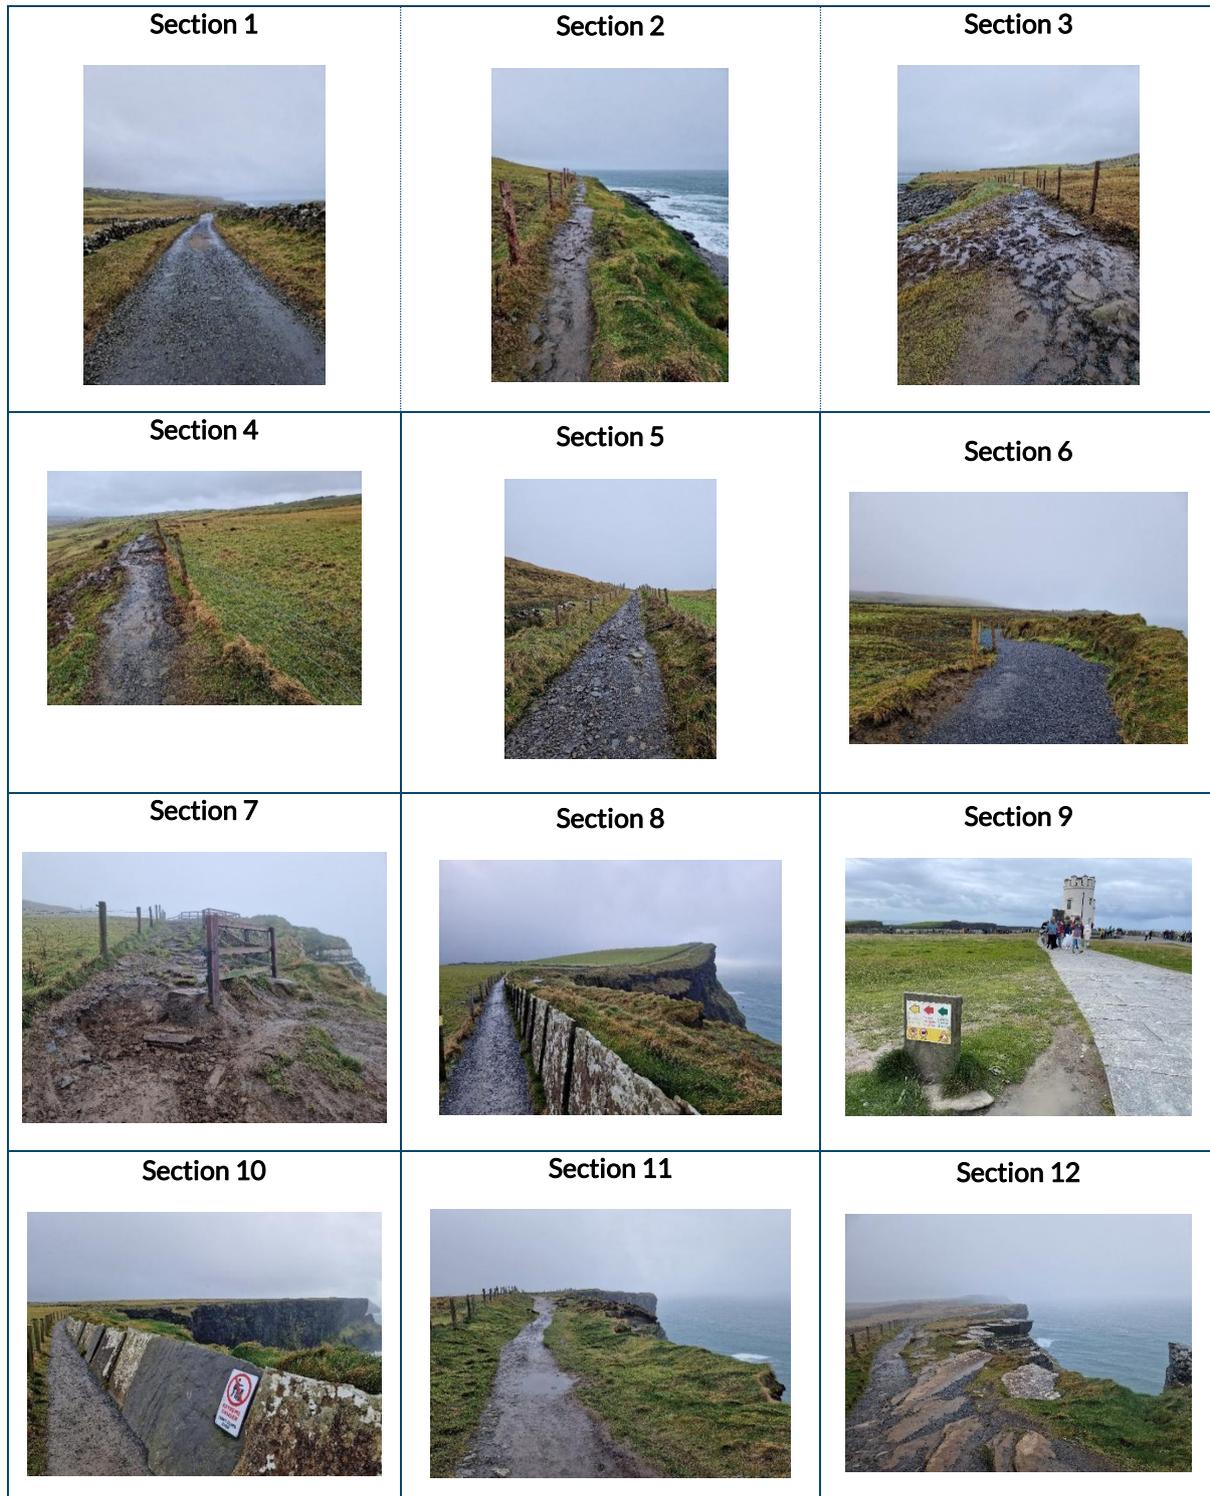
Figure 6-2: Representative Photos of Trail Sections

Representative views of each of these sections are presented below.

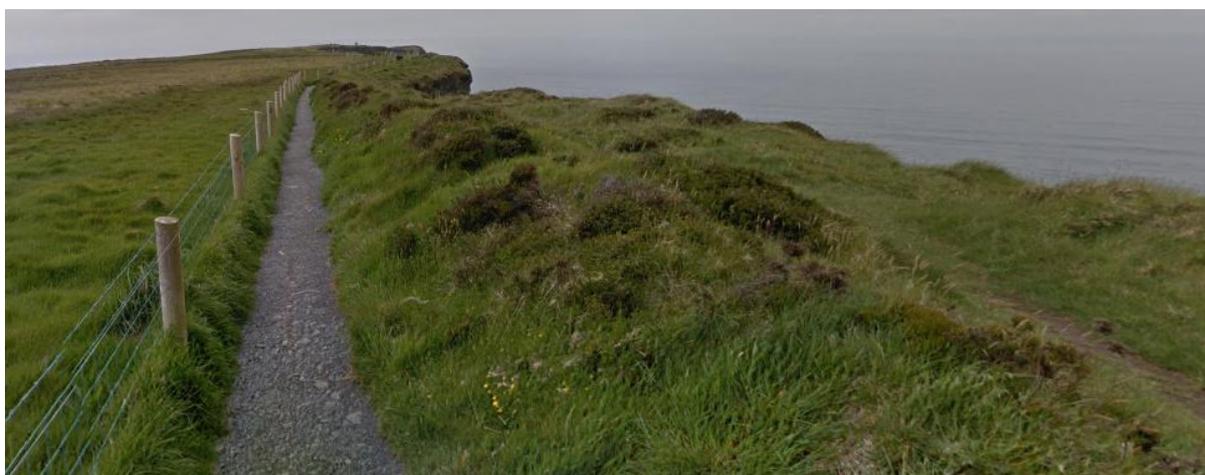
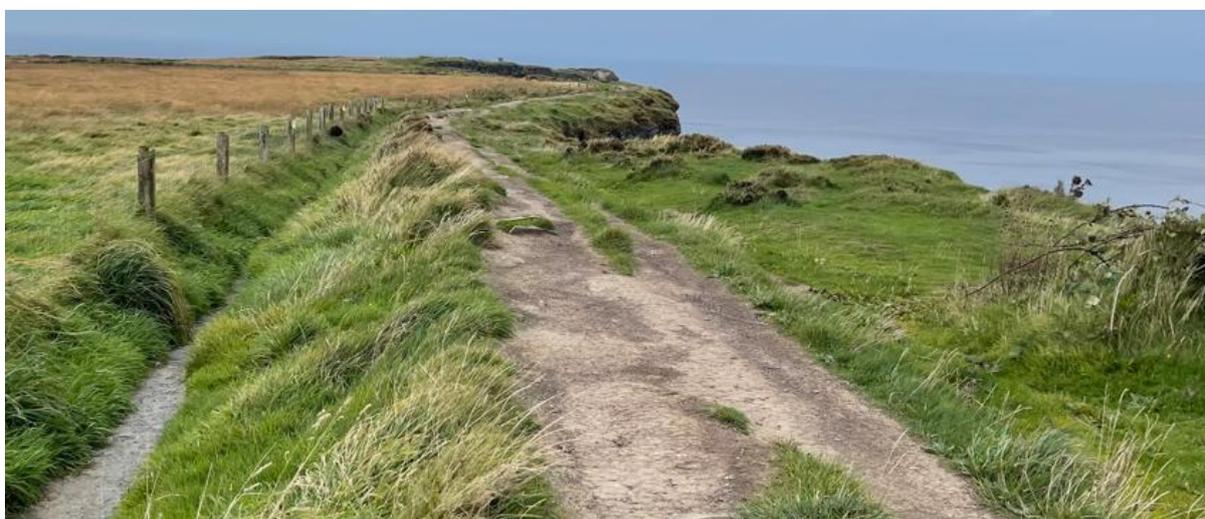
Figure 6-3: Unofficial Trail Example, Chainage 8250 (top: from Google, 2014, bottom: from walkover 2024)

A significant issue along the walk, and in particular on the southern section is the existence of areas of worn ground that can be described as unofficial trails. These unofficial trails have formed at certain locations as a result of:

These unofficial trails have caused extensive damage to existing biodiversity and has accelerated in recent years as numbers on the coastal walk have increased. A good example is shown below at Chainage 8250, over a 10-year period from 2014 to 2024.

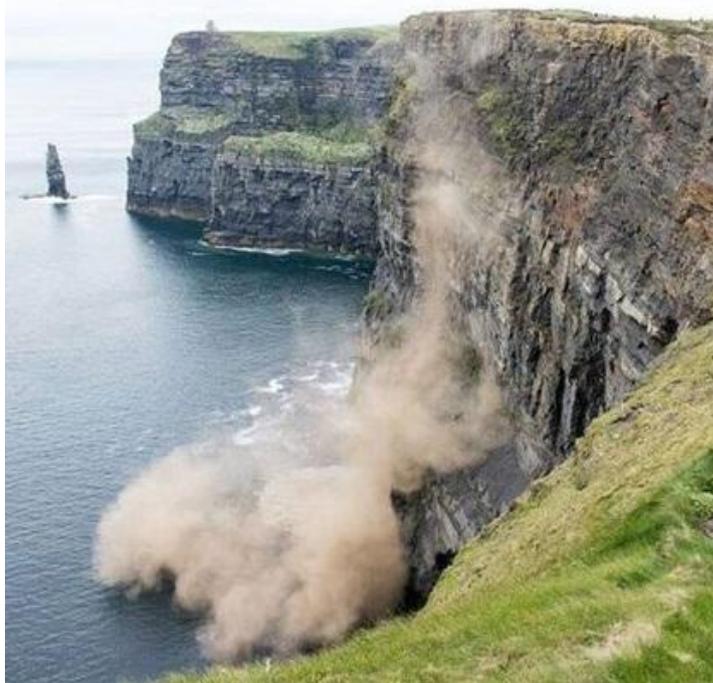
Figure 6-6: Landslide along the Cliffs in 2016 (source, Burren Geopark)

Information and photos on the Geopark website points to a number of historical landslides along the Cliffs of Moher, including in the summer of 2016, as evidenced by the photo below.

That report concluded that failures are occurring in both the soil and rock along the entire cliff face at the Cliffs of Moher. Soil failures were attributed to unstable angles of the residual shale soil, while rock failures were attributed to ongoing wave, wind and rain erosion, resulting in undercutting of the rock mass and widening of major joint sets.

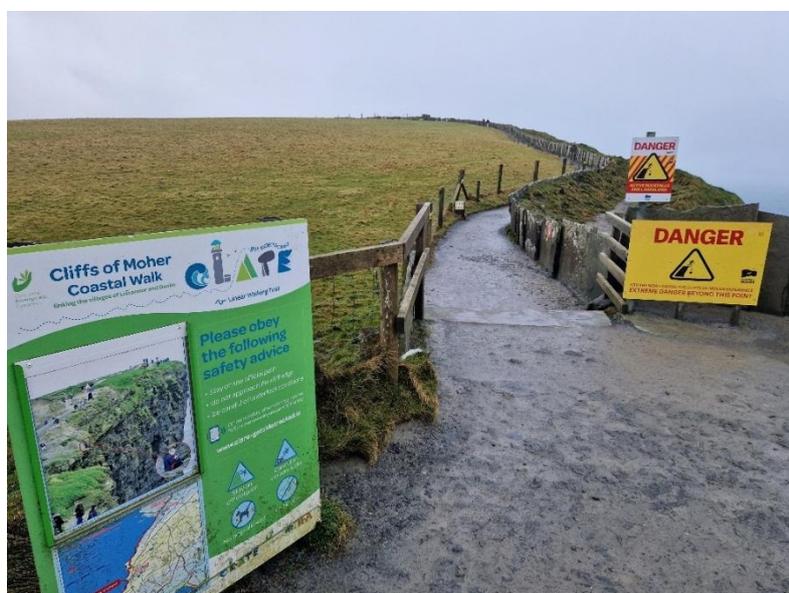
Figure 7-2: Official COMCW Signage at Entrance from COME

At present, signage at the Cliffs of Moher Experience is dominated by aspects other than the walk and it is difficult to identify the start points of the walk. The exit points from the Cliffs of Moher Experience, onto the Cliffs of Moher Coastal Walk (which technically runs through the Visitor's Centre area) are clearly marked.

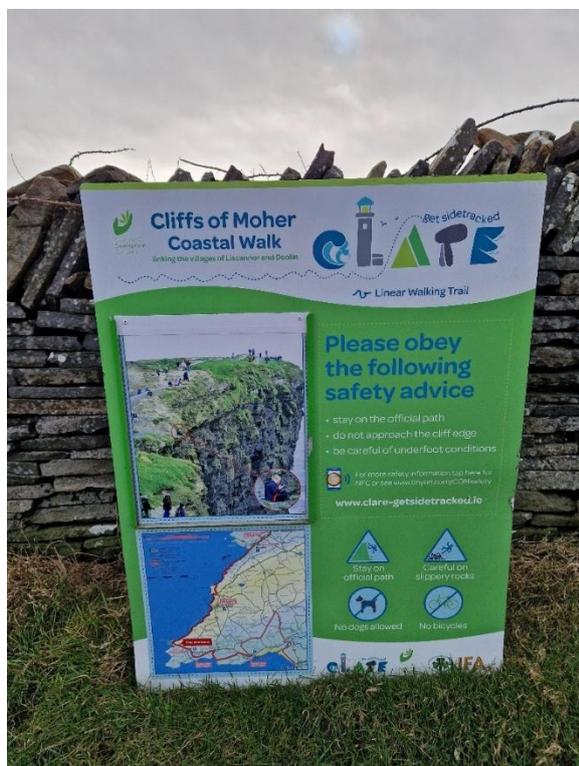
Figure 7-3: Official COMCW Signage at Hags Head

These two 'terminal' points are different from each other. At Hags Head parking is available at a privately operated car park. There is no official Cliffs of Moher Coastal Walk signage at this car park but the route to the cliffs along the roadway is obvious. A further 570m along roadway, an official Cliffs of Moher Coastal Walk sign has been erected, as shown below.

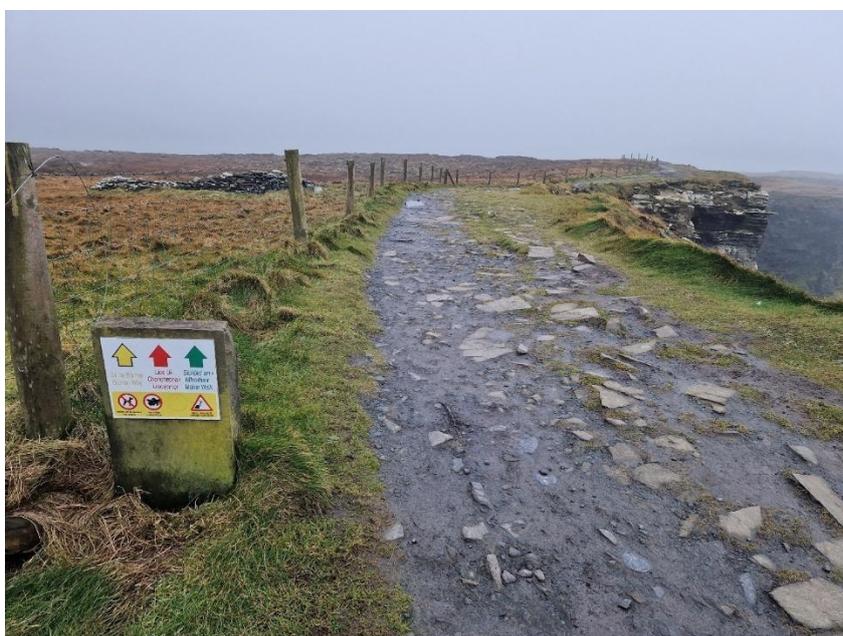
Figure 7-4: Existing Directional Signage

At present, other than the entry signs at Hags Head and Doolin, there are no official directional signs along the Coastal Walk. There are a number of small directional signs located along the trail, as shown below, using the following colour system:

- **Yellow**, indicating the Burren Way
- **Red**, indicating the direction of Liscannor or Doolin (taken presumably from The Doolin to Liscannor Coastal Walk)
- **Green**, indicating The Moher Walk (a title which is not explained on any mapping)

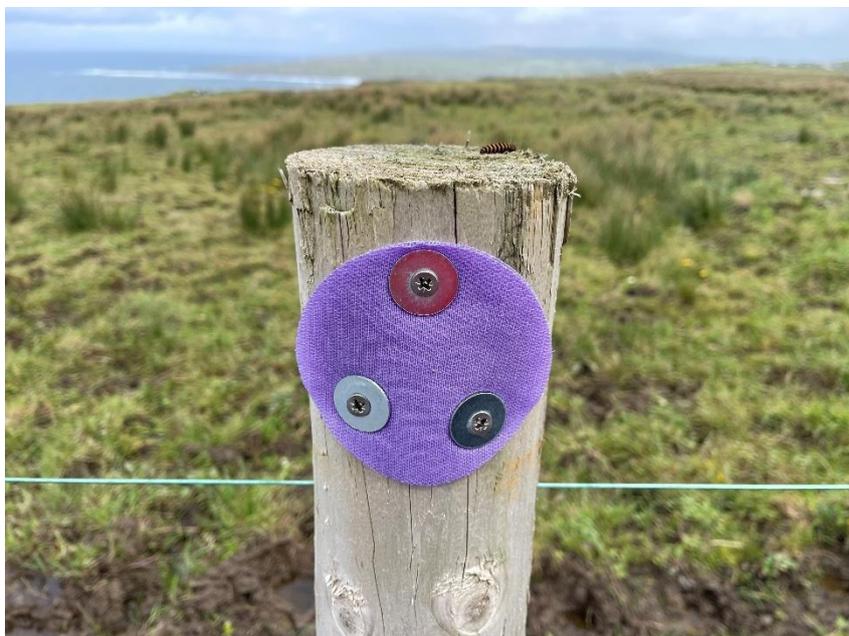
Figure 7-5: Existing Colour Coding 'Zone' Markers

In response to the concerns around a lack of location markers on the walk, Clare County Council, as an interim step, and in consultation with the emergency services, proposed a temporary solution consisting of a colour coded system that divided the walk into discrete zones. These zones were generally dictated by access locations, with the colour changing at each access point. Marker plates consist of circular colour markers are mounted on fence posts, as shown below.

Mapping showing these colour zones is available to the emergency services (as that was the intended purpose), but the system has not yet been adopted for users of the Coastal Walk.

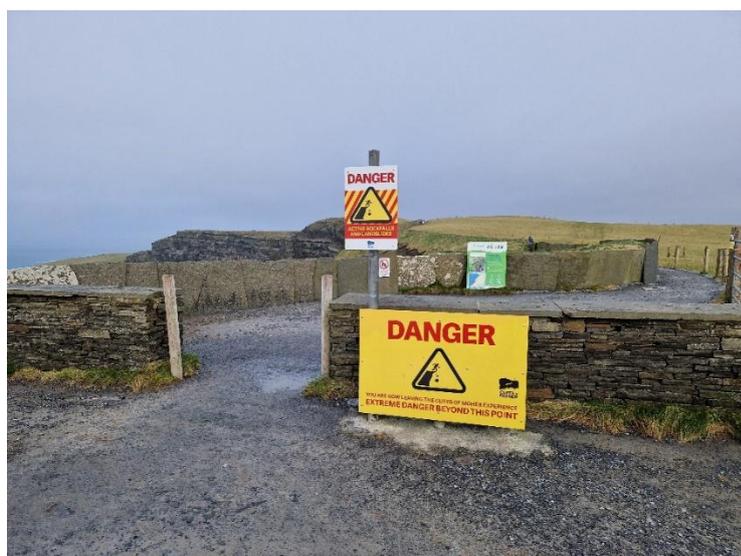
Figure 7-6: Safety Sign at Exit from COME area (sample)

- In many locations, and in particular remote from the COME, it is unclear where the alignment of the approved trail lies
- The safety signs at exit points from the COME do not set out a system for designating the approved trail
- Some safety signs are too low and could be missed by walkers
- Safety signs have no unified appearance and are missing clear branding (such as the new Cliffs of Moher logo)
- Safety signs are not designed to an internationally recognised iconography

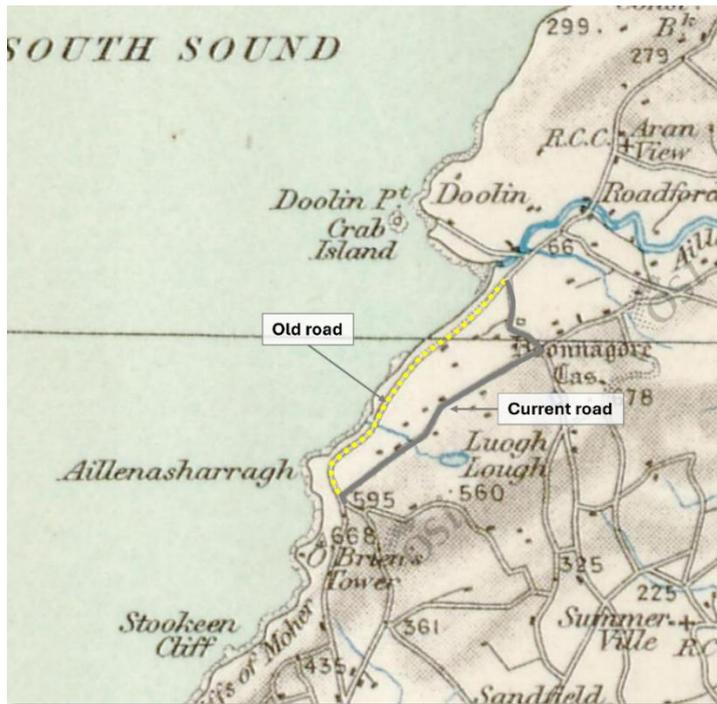
Figure 8-1: Old Doolin to Liscannor Road (in yellow)

It is noted that an old road from Doolin to Liscannor ran along the route shown in the image below and was still in use in the early part of the 20th century.

This old road is still in place and is used by landowners. In most locations the road corridor is approximately 6.5m wide and the foundation of the road seems to be still intact, but the road surface has gradually grassed over. No building has taken place along this corridor, and it would be technically feasible to reconstitute the corridor as part of the Coastal Walk.

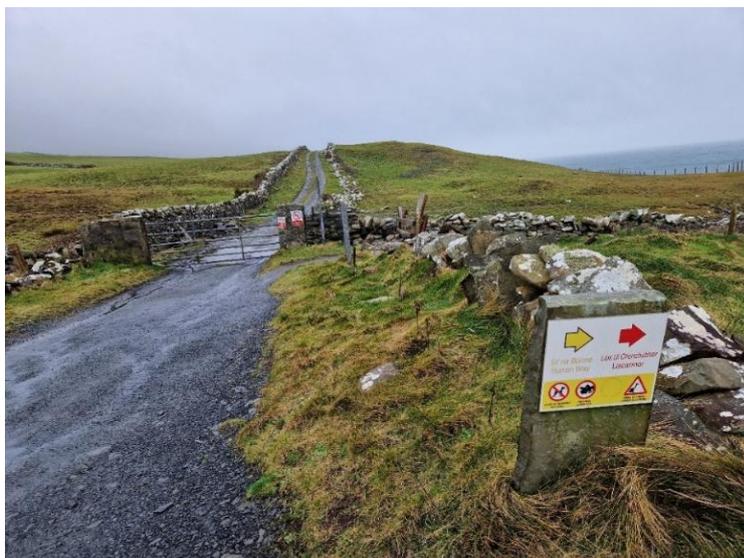
Figure 8-2: Old Doolin to Liscannor Road (background) at Chainage 1070

While this would represent a significant change to the character of the Coastal Walk in that it would not run along the cliff edge, the route enjoys excellent views of the Aran Islands and would be attractive to walkers. The point at which the Coastal Walk departs from the old road is shown below (Chainage 1070).

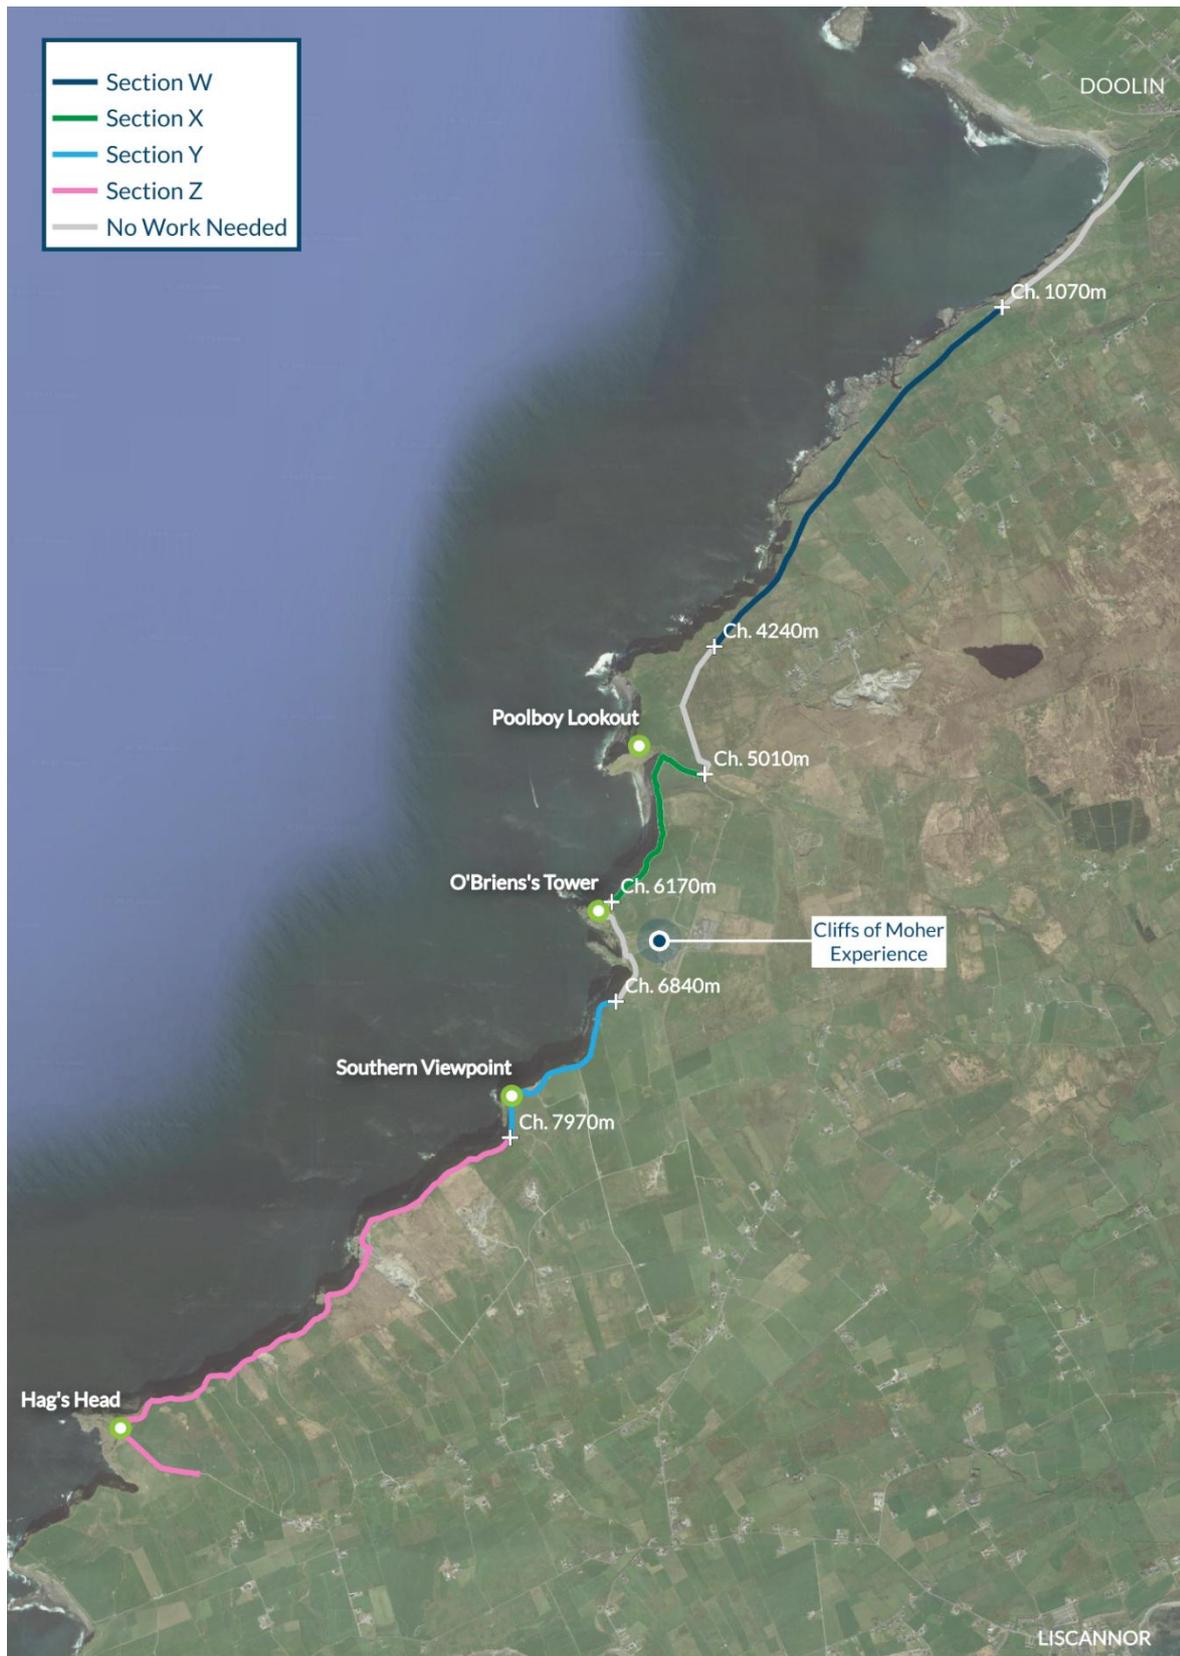
Figure 8-4: Future Trail Upgrade Sections

- **Section Z**, comprising the remainder of the trail route south from Chainage 7970 to Chainage 11430 Hags Head

These sections are shown in the image below. Sections X and Y can be considered the future *Control Zone*, comprising the heavily trafficked sections, while Sections W and Z lie outside this Control Zone, but are also an integral part of the Coastal Walk.

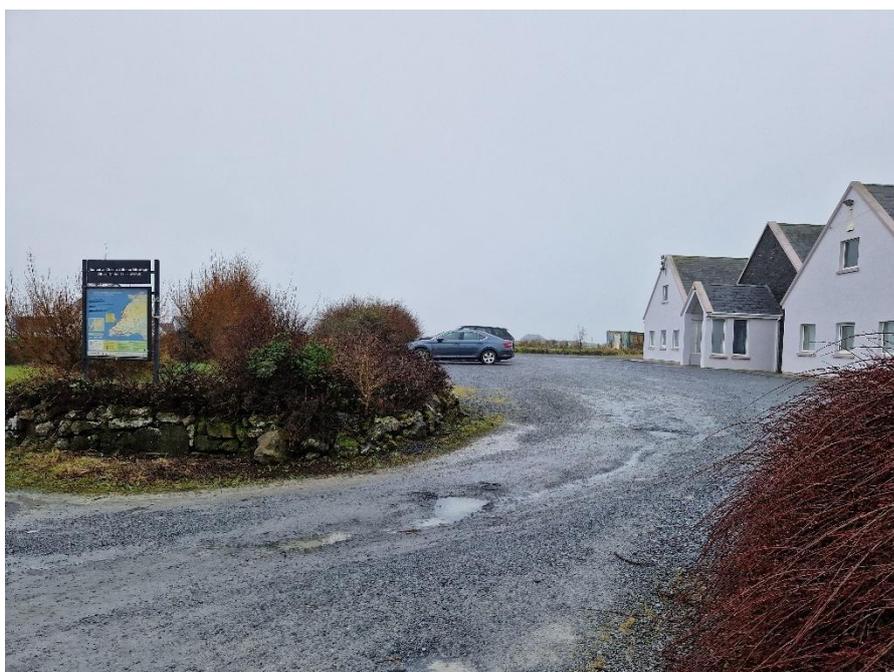
Figure 9-1: Doolin Trailhead

The official start of the Cliffs of Moher Coastal Walk is at the Doolin Community Centre located 1.5km north of the bridge at Fisher Street and containing 30 parking spaces (see photo below).

Most walkers would consider the vicinity of the bridge at Fisher Street to be the de facto start of the trail, while the 'true' trail starts at the off-road section 400m south-west of the bridge. For this reason, the parking facilities available at Doolin Community Centre are not typically used by walkers on the Coastal Walk.

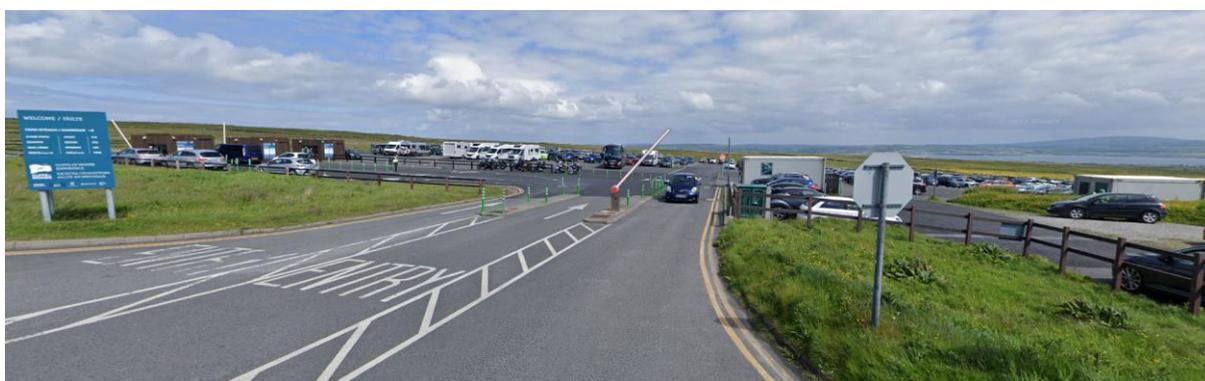
Figure 9-2: Cliffs of Moher Experience Trailhead

As outlined in the Cliffs of Moher 2040 Strategy, there is only one car park for visitors to the COME, located across the road on the eastern side of the R478. This car park has capacity for approximately 480 vehicles.

Coach parking is located on the western side of the R478 at the COME and can accommodate 28 vehicles.
