Cliffs of Moher Coastal Walk

Management Plan

Final Issue

April 2025

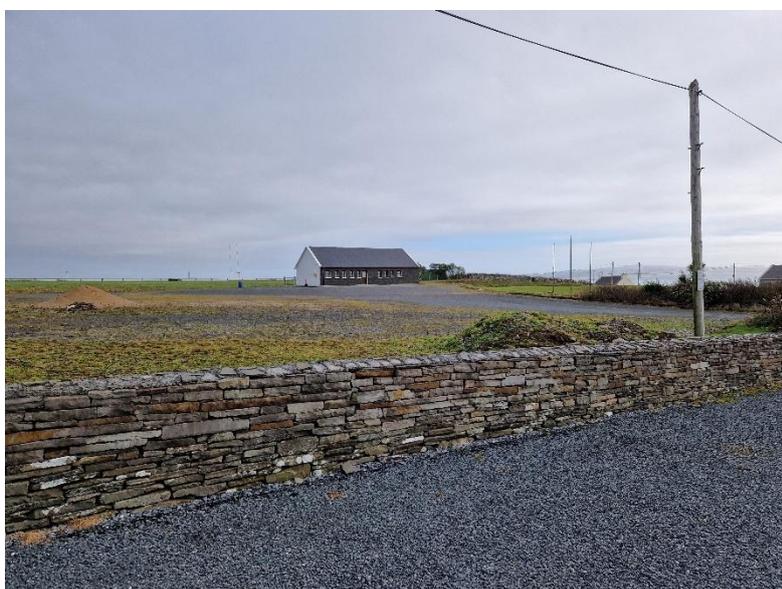
Figure 9-3: Liscannor Trailhead at Moher GAA (parking in foreground)

At the Liscannor end of the trail, the official trailhead is at the Moher GAA grounds and there are approximately 18 parking spaces available along the edge of the public road at this location (foreground of the photo below). The main car park in the GAA grounds is not available for public parking and the gates of the facility are generally locked.

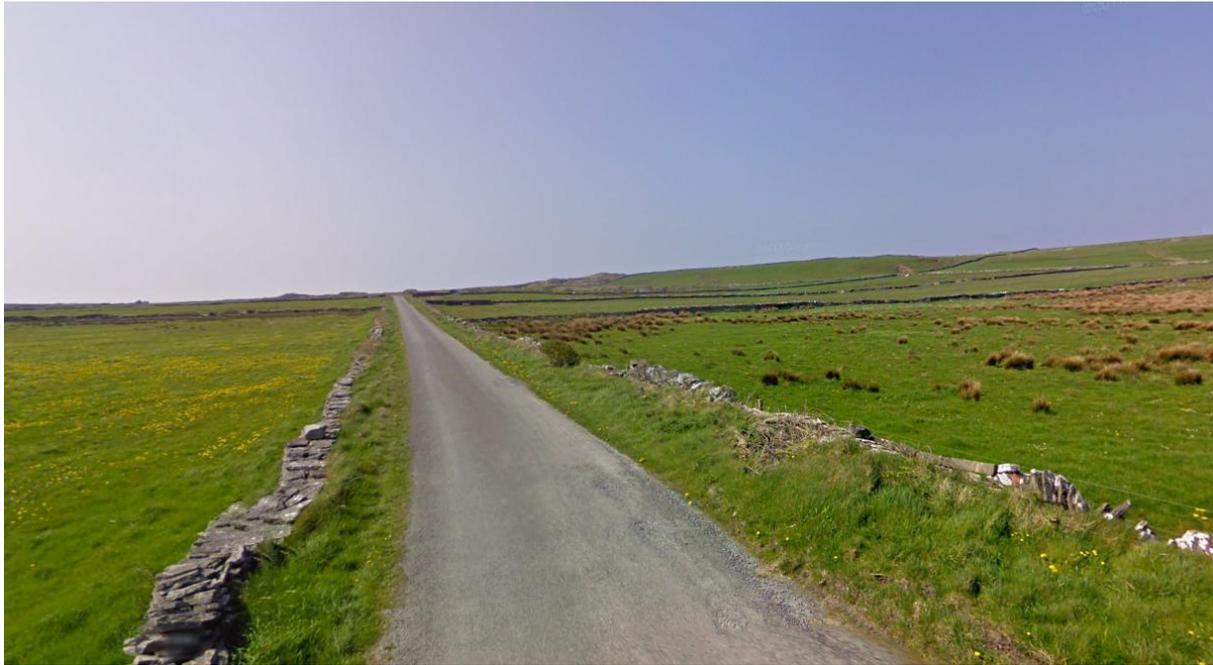
Figure 9-7: Local Road at Slievenageeragh (location of uncontrolled parking)

- A small number of visitors avoiding the paid admission at the COME
- Information shared on social media pointing visitors to this area and the option of avoiding parking charges at the COME
- The close proximity of these local roads to the highest points of the cliffs. In some places it is less than 400m from the local road to the cliffs.

In response to these concerns Clare County Council has tried to control parking by erecting No Parking signage and by employing Traffic Wardens during peak season. This has had some effect, but the problem persists at peak times.

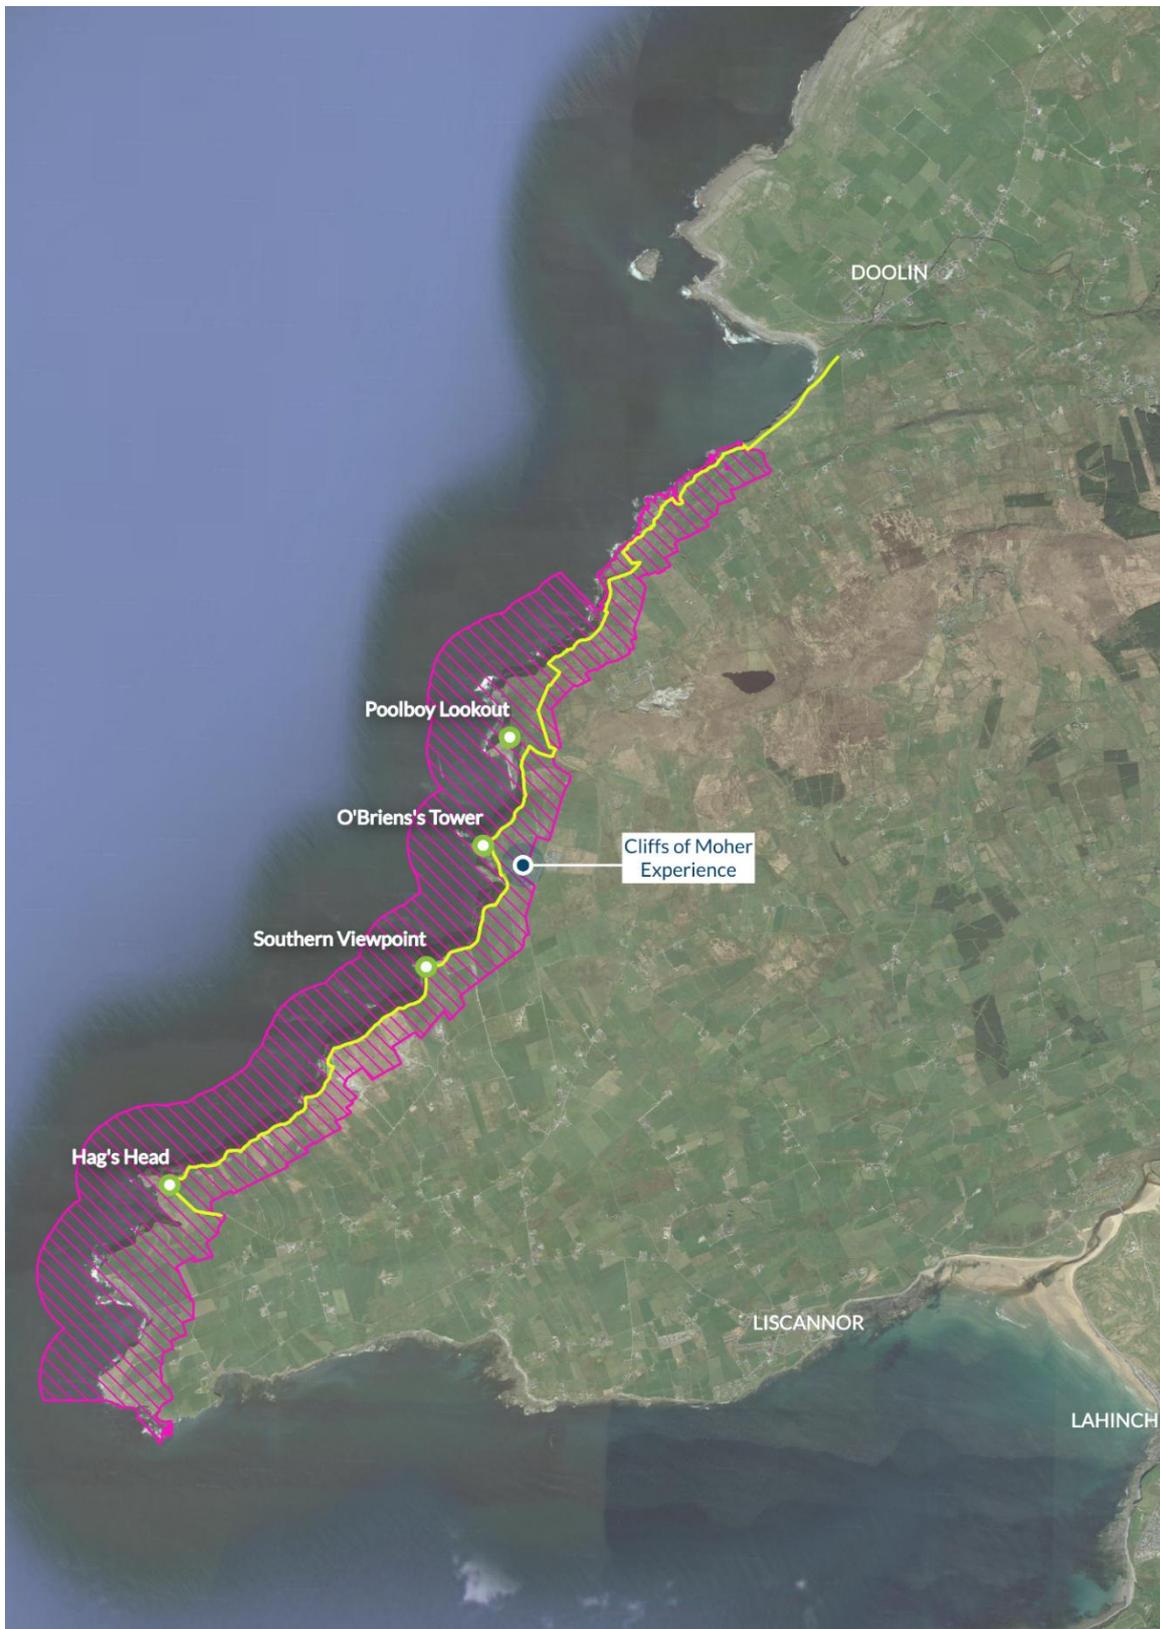
Figure 10-1: Natura 2000 Sites along the Coastal Walk

The Cliffs of Moher is a Proposed Natural Heritage Areas (pNHA), site code: 000026 under the Wildlife Act. The boundary of the pNHA generally lies within the SPA boundary but only extends a short distance inland (approx. 10m to 20m).

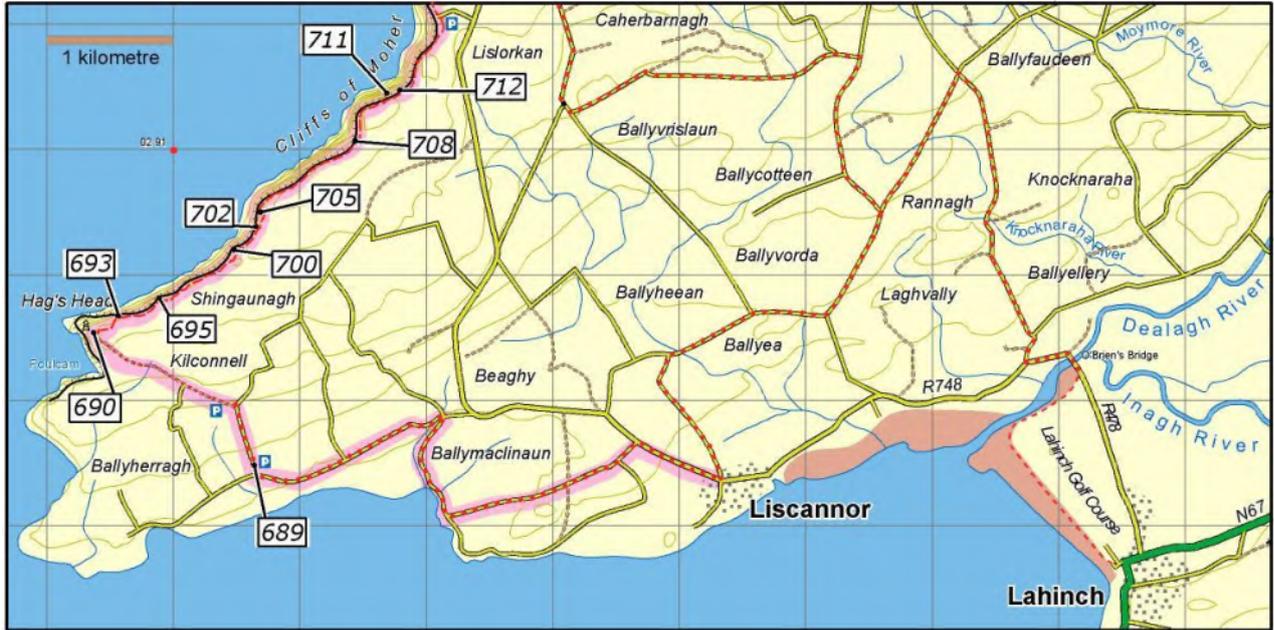
Cliffs of Moher Coastal Walk : Map 1

The map(s) below show the locations of any Potential Safety Issues and other Significant Issues identified and discussed during the audit.

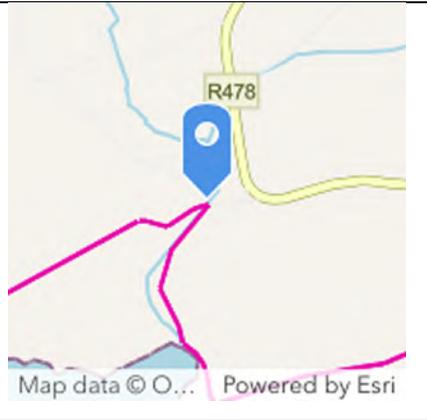
24-670-006		
Severity		
Significant		
Category		
Waymarking Issue		
Issue		
Missing/Needed		
Coordinates*		
52.94261, -9.42647		
Location: As discussed during inspection & shown on map		
Comment: None

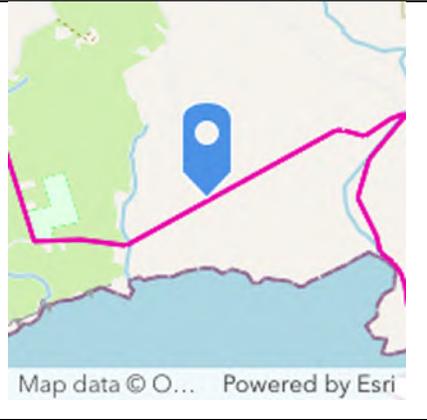
24-670-007		
Severity		
Significant		
Category		
Waymarking Issue		
Issue		
Hidden/Very Faded		
Coordinates*		
52.93939, -9.43827		
Location: As discussed during inspection & shown on map		
Comment: Straight on yellow arrows on black background mounted on telegraph pole needed as existing signage prone to disappearing among roadside vegetation.

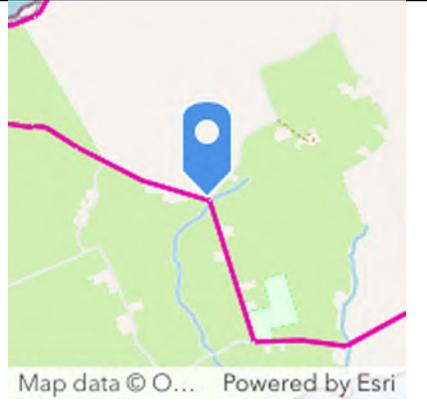
24-670-009			
Severity			
Significant			
Category			
Waymarking Issue			
Issue			
Broken/Damaged/Collapsed			
Coordinates*			
52.94304, -9.45141			
Location: As discussed during inspection & shown on map			
Comment: None

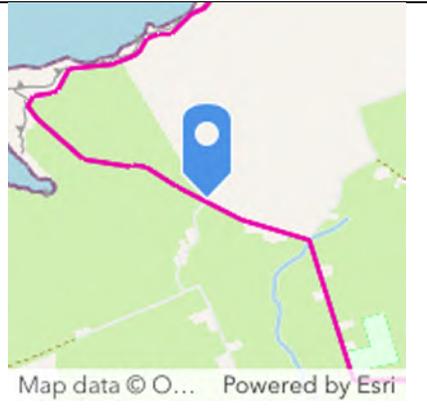
24-670-010			
Severity			
Significant			
Category			
Waymarking Issue			
Issue			
Missing/Needed			
Coordinates*			
52.94438, -9.45736			
Location: As discussed during inspection & shown on map			
Comment: Straight on arrows needed

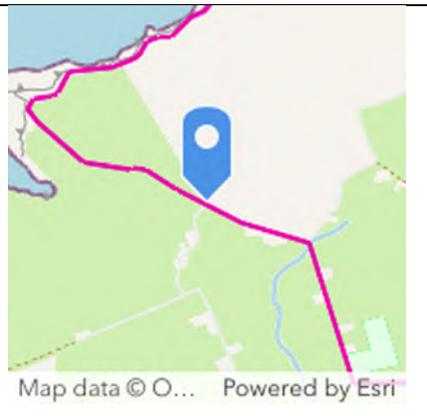
24-670-010A			
Severity			
Safety			
Category			
Signage			
Issue			
Missing/Needed			
Coordinates*			
52.94438, -9.45736			
Location: At gate from public roadway onto start of Cliffs of Moher Walking Trail			
Comment: Warning signs needed on this gate using internationally understood infographics alerting trail users to the dangers of the cliff walk. The existing signs only refer to car parking.

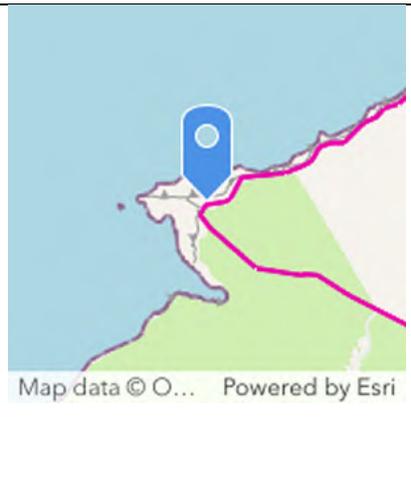
Severity			
Safety			
Category			
Signage Issue			
Issue			
Hazard without Warning Signs e.g. Dangerous cliffs, mines or tidal areas			
Coordinates*			
52.94821, -9.46766

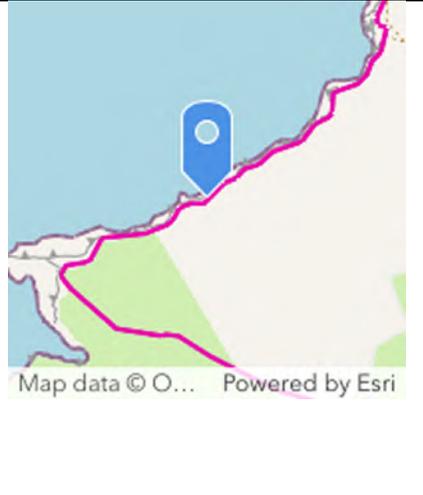
Severity	Safety		
Category	Signage Issue		
Issue	Hazard without Warning Signs e.g. Dangerous cliffs, mines or tidal areas		
Coordinates*	52.95053, -9.45932		
Location: As discussed during inspection & shown on map			
Comment: A wedding ceremony was underway at the time of inspection close to the cliff edge off the official path. Events such as these should not be permitted. What appears to trail users as an official event sends out the wrong message that it is ok to stray from the official path and to stand close to the cliff edge.

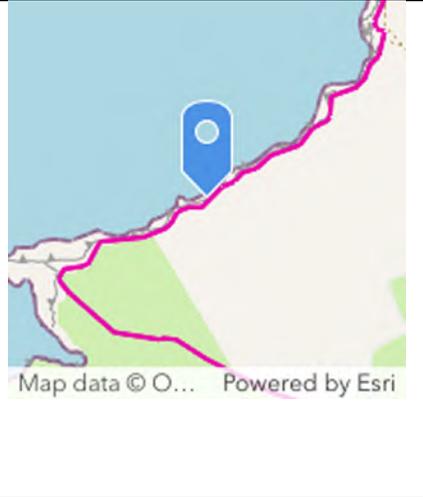
24-670-018		
Severity		
Safety		
Category		
Signage Issue		
Issue		
Hazard without Warning Signs e.g. Dangerous cliffs, mines or tidal areas		
Coordinates*		
52.95067, -9.45920		
Location: North of Hag's Head.		
Comment: This is a pinch point on the trail where the official and unofficial paths meet briefly and are not distinguishable by trail surface. Warning signage is needed to divert walkers back onto the official trail at each side of this point and ultimately the trail should be upgraded/re-routed so that the official path is back from the cliff edge, does not go around a pinch point and is clearly differentiated from the unofficial path.

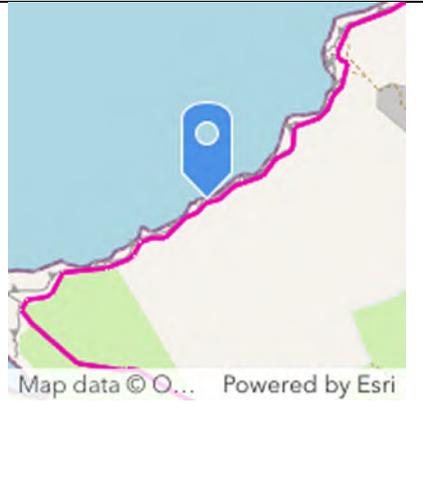
24-670-019		
Severity		
Safety		
Category		
Signage Issue		
Issue		
Hazard without Warning Signs e.g. Dangerous cliffs, mines or tidal areas		
Coordinates*		
52.95172, -9.45699		
Location: North of Hag's Head.		
Comment: The photograph shows a well used unofficial path leading to cliff edge with no warning signs present. Warning signs and signs to stay on the official path needed here.

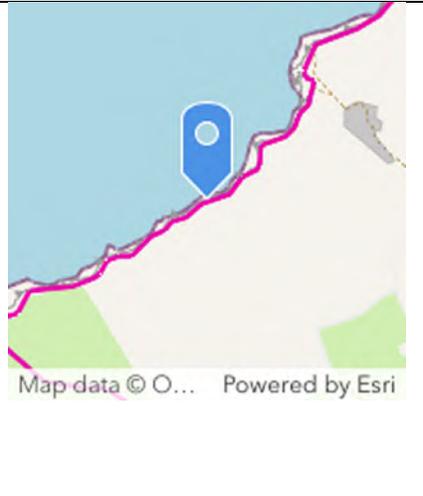
24-670-021		
Severity		
Safety		
Category		
Signage Issue		
Issue		
Hazard without Warning Signs e.g. Dangerous cliffs, mines or tidal areas		
Coordinates*		
52.95238, -9.45499

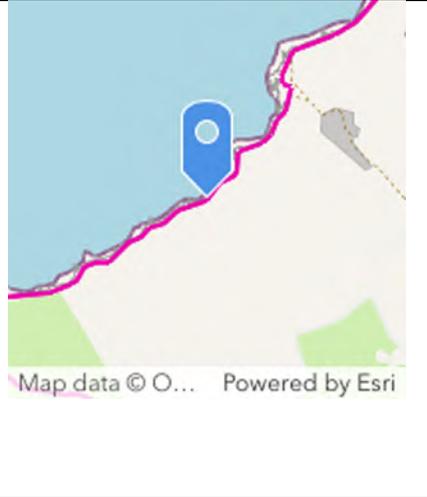
Severity	Safety		
Category	Signage Issue		
Issue	Hazard without Warning Signs e.g. Dangerous cliffs, mines or tidal areas		
Coordinates*	52.95266, -9.45363		
Location: North of Hag's Head.			
Comment: Fencing and warning signage needed here where the ground drops away at a steep angle from the path very close to the cliff edge posing a safety issue even for those walkers who do not leave the official trail.

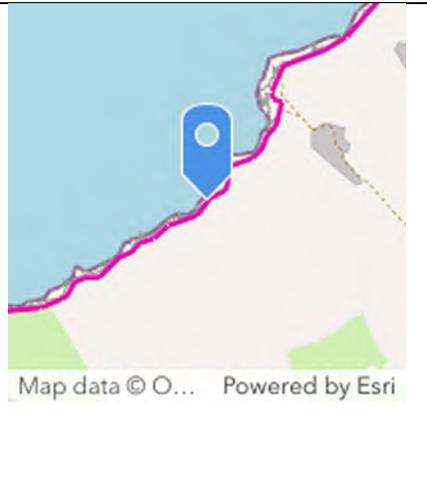
Severity	Safety		
Category	Signage Issue		
Issue	Hazard without Warning Signs e.g. Dangerous cliffs, mines or tidal areas		
Coordinates*	52.95310, -9.45306		
Location: North of Hag's Head.			
Comment: Trail users leave the official trail here to stand on the rock platforms close to the cliff edge. Warning signs needed and arrows directing walkers to stay on the official trail.

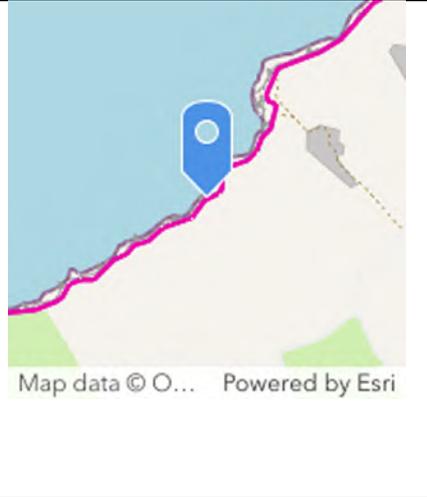
24-670-024		
Severity		
Safety		
Category		
Signage Issue		
Issue		
Hazard without Warning Signs e.g. Dangerous cliffs, mines or tidal areas		
Coordinates*		
52.95328, -9.45274		
Location: North of Hag's Head.		
Comment: This is an extremely dangerous point on the trail where an unofficial path leads to a point right on the cliff edge not visible to walkers approaching from the south. This point needs to be fenced off with warning signs and directional arrows warning walkers to stay on the official trail.

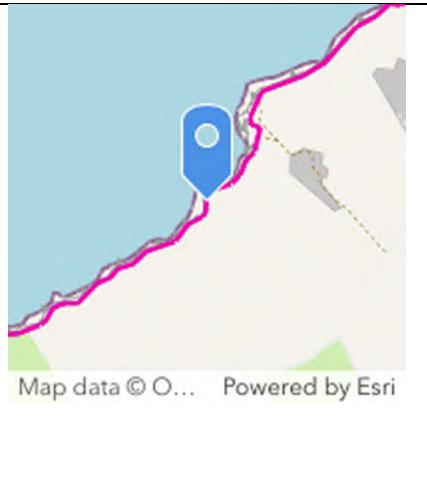
24-670-025		
Severity		
Safety		
Category		
Signage Issue		
Issue		
Hazard without Warning Signs e.g. Dangerous cliffs, mines or tidal areas		
Coordinates*		
52.95399, -9.45176		
Location: North of Hag's Head.		
Comment: Many walkers were observed leaving the official trail here to stand on a cliff overhang. Warning signs/fencing needed here to warn trail users to stay on the official trail.

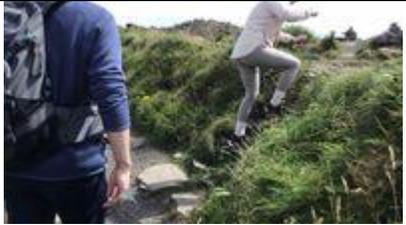
24-670-031		
Severity		
Safety		
Category		
Signage Issue		
Issue		
Hazard without Warning Signs e.g. Dangerous cliffs, mines or tidal areas		
Coordinates*	52.95681, -9.44895

Location: North of Hag's Head.

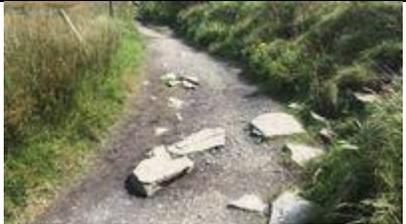
24-670-032		
Severity		
Safety		
Category		
Surface Issue		
Issue		
Wet, Muddy or Boggy		
Coordinates*	52.95681, -9.44895

Location: The same location as the previous issue

Comment: This section of the trail is prone to flooding and becoming waterlogged and muddy making the unofficial trail close to the cliff edge a more attractive route. Trail upgrade needed to prevent flooding and signage needed to warn walkers not to climb the barrier.

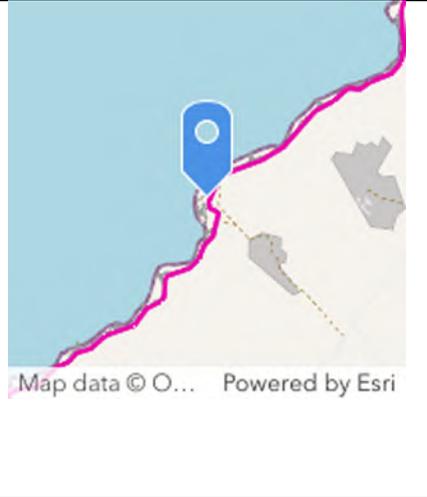
Severity			
Safety	Safety		
Category	Signage Issue		
Issue	Hazard without Warning Signs e.g. Dangerous cliffs, mines or tidal areas		
Coordinates*	52.95715, -9.44929		
Location: North of Hag's Head.			
Comment: The photograph is taken looking north along the trail with the cliff edge to the left. The majority of trail users can be seen using the much wider unofficial path. The official path is too narrow for the large numbers using the trail and there are no warning signs directing walkers not to cross the barrier.

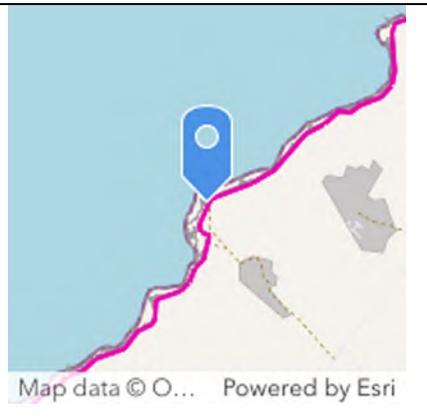
Severity			
Safety	Safety		
Category	Surface Issue		
Issue	Wet, Muddy or Boggy		
Coordinates*	52.95781, -9.44873		
Location: North of Hag's Head.			
Comment: Looking north along the trail the photograph shows the majority of trail users walking the unofficial path at the top of the high earthen barrier. The official trail on the right is waterlogged and very narrow and there are no warning signs directing walkers not to climb up to the unofficial path. This trail surface here needs to be upgraded and the trail widened to allow for the large number of trail users.

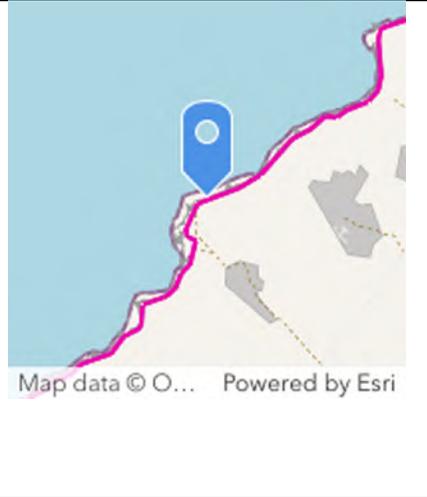
Severity			
Safety	Safety		
Category	Signage Issue		
Issue	Hazard without Warning Signs e.g. Dangerous cliffs, mines or tidal areas		
Coordinates*	52.95816, -9.44792		
Location: North of Hag's Head.			
Comment: The photograph is taken looking south along the trail with the cliff edge to the right. Multiple trail users can be seen climbing off the official trail which is located behind the high earthen barrier to the left. There is no warning signage here directing people to keep left and stay on the official trail.

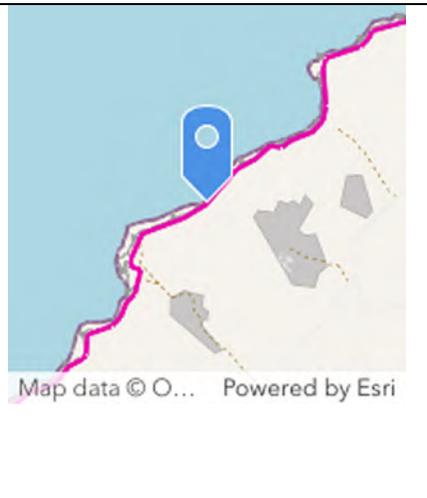
Severity			
Safety	Safety		
Category	Signage Issue		
Issue	Hazard without Warning Signs e.g. Dangerous cliffs, mines or tidal areas		
Coordinates*	52.95906, -9.44463		
Location: North of Hag's Head.			
Comment: the photograph is taken looking north along the trail with the cliff edge to the left. Multiple unofficial paths are visible to the left and the official trail surface merges with these to widen into a path that comes close to the cliff edge with no warning signs.

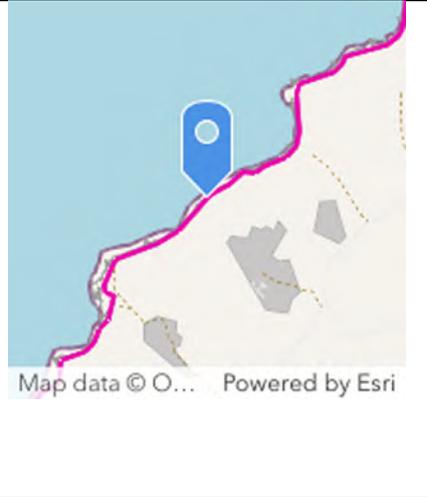
Severity			
Safety			
Category	Signage Issue		
Issue	Hazard without Warning Signs e.g. Dangerous cliffs, mines or tidal areas		
Coordinates*	52.96015, -9.44304		
Location: North of Hag's Head.			
Comment: The photograph is taken looking north along the trail with the cliff edge to the left. Here it is difficult to distinguish between the official and unofficial trails as the surfaces are the same and the path to the right is very narrow. A trail upgrade is needed here to widen the official trail, clearly distinguishing it with a different trail surface from any adjacent unofficial paths and provide warning signage to keep right.

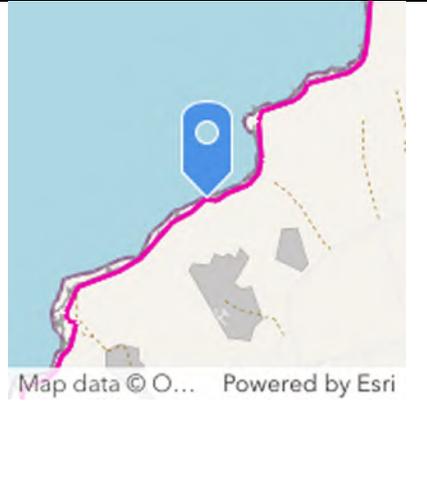
Severity			
Safety			
Category	Signage Issue		
Issue	Hazard without Warning Signs e.g. Dangerous cliffs, mines or tidal areas		
Coordinates*	52.96112, -9.44078		
Location: North of Hag's Head.			
Comment: The photograph is taken looking north along the trail with the cliff edge to the left. Here the official trail to the right is through a 'stile' made of two flagstones placed in an upturned V. This presents a visual barrier to the trail user and presents an unnecessary obstacle. This stile should be removed. The warning signage should be accompanied by a fence preventing walkers from using the very dangerous unofficial trail to the left.

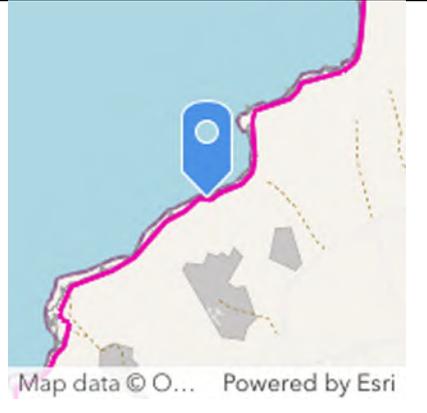
24-670-039		
Severity		
Safety		
Category		
Route Issue		
Issue		
Other		
Coordinates*		
52.96111, -9.44040

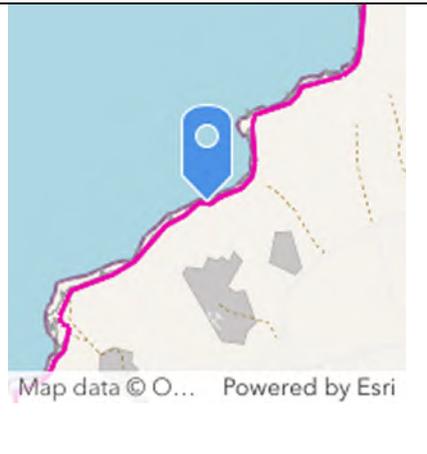
24-670-040		
Severity		
Safety		
Category		
Fencing Issue		
Issue		
Barbed Wire that may injure a Walker		
Coordinates*		
52.96111, -9.44039

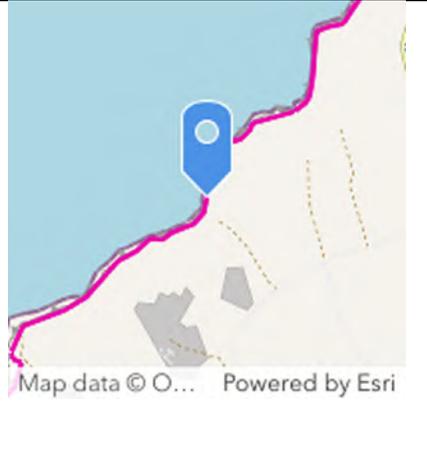
24-670-043		
Severity		
Safety		
Category		
Fencing Issue		
Issue		
Barbed Wire that may injure a Walker		
Coordinates*	52.96254, -9.43751	
Location: North of Hag's Head.		
Comment: Barbed wire could cause injury to walkers forced to move in close to the fence when leaving way for walkers going in the opposite direction. The official trail needs to be upgraded and widened and barbed wire removed from fencing.

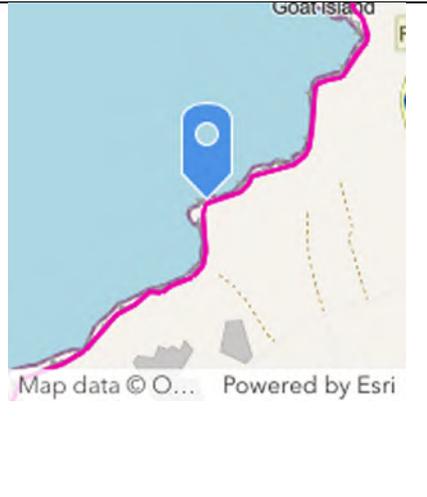
24-670-044		
Severity		
Safety		
Category		
Signage Issue		
Issue		
Hazard without Warning Signs e.g. Dangerous cliffs, mines or tidal areas		
Coordinates*	52.96438, -9.43746	
Location: North of Hag's Head.		
Comment: The photograph is taken looking south along the trail with the cliff edge to the right. It shows trail users climbing back off the official path through a break in the barrier. The broken section of barrier should be repaired and signage erected reminding walkers to stay on the official path and not to cross the barrier.

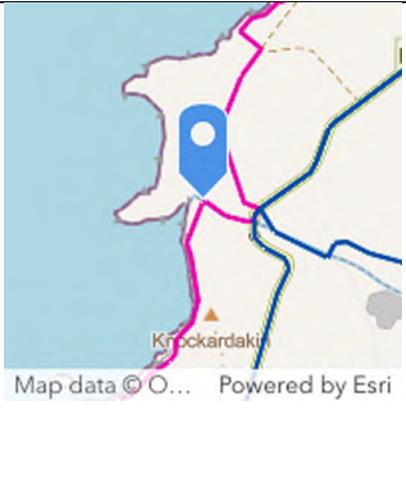
Severity			
Safety			
Category	Signage Issue		
Issue	Hazard without Warning Signs e.g. Dangerous cliffs, mines or tidal areas		
Coordinates*	52.98063, -9.42564		
Location: : North of the Cliffs of Moher Visitor Centre just before the trail leaves the cliffs to move briefly inland.			
Comment: Left turn waymarking is needed here and warning signs to stay on the official trail.

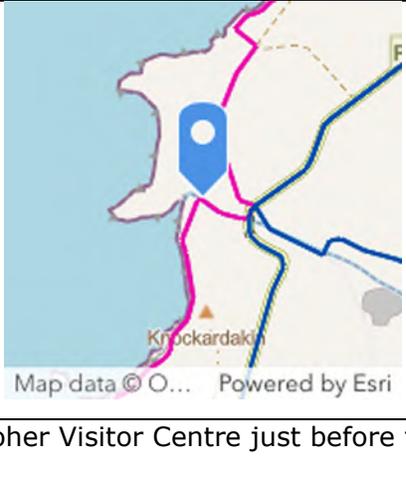
Severity			
Significant			
Category	Waymarking Issue		
Issue	Not Clearly Visible on Approach		
Coordinates*	52.98059, -9.42535		
Location: North of the Cliffs of Moher Visitor Centre just before the trail leaves the cliffs to move briefly inland.			
Comment: Clear left turn arrow needed. At the point where the trail turns left (when going south) there is no left turn waymarker and walkers could walk straight on onto the unofficial path leading to the cliffs

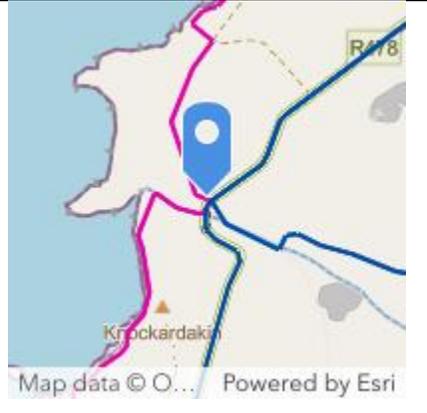
24-7-056		
Severity		
Significant		
Category		
Waymarking Issue		
Issue		
Missing/Needed		
Coordinates*		
52.98042, -9.42250		
Location: North of the Cliffs of Moher Visitor Centre		
Comment: Left turn brown finger post sign Burren Way waymarking needed here.

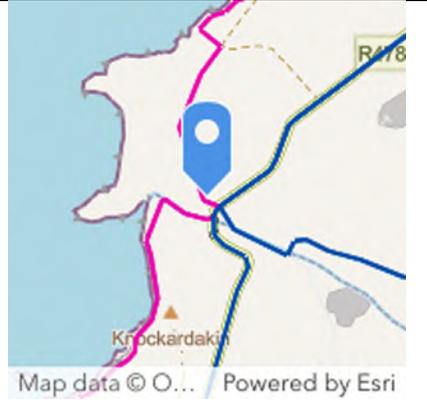
24-7-057		
Severity		
Significant		
Category		
Waymarking Issue		
Issue		
Missing/Needed		
Coordinates*		
52.98063, -9.42299		
Location: North of the Cliffs of Moher Visitor Centre.		
Comment: Straight on waymarking arrows needed here for Cliffs of Moher Coastal Walk and Burren Way to direct walkers to the left of the outbuilding where the stile is located.

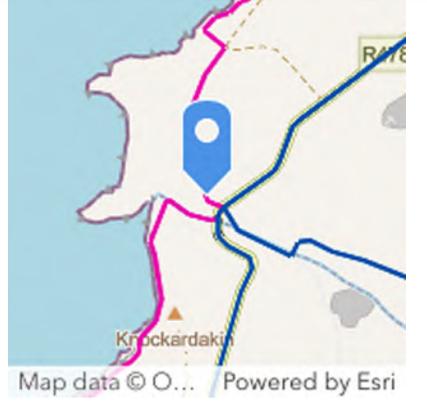
24-7-058		
Severity		
Significant		
Category		
Waymarking Issue		
Issue		
Missing/Needed		
Coordinates*		
52.98070, -9.42323		
Location: North of the Cliffs of Moher Visitor Centre.		
Comment: Straight on waymarking arrows needed here for Cliffs of Moher Coastal Walk and Burren Way to direct walkers to the left of the outbuilding where the stile is located.

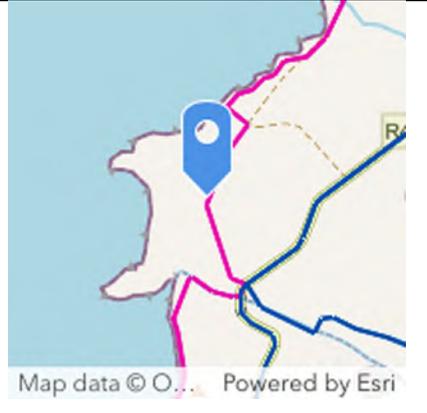
24-7-059		
Severity		
Significant		
Category		
Waymarking Issue		
Issue		
Missing/Needed		
Coordinates*	52.98342, -9.42461	
Location: North of the Cliffs of Moher Visitor Centre.		
Comment: Right turn waymarking arrows needed here for Cliffs of Moher Coastal Walk and Burren Way at stile

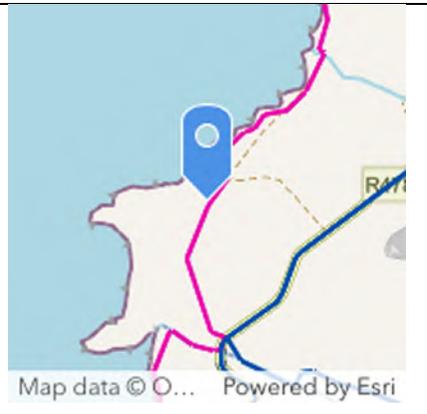
24-7-060		
Severity		
Significant		
Category		
Waymarking Issue		
Issue		
Missing/Needed		
Coordinates*	52.98521, -9.42343	
Location: North of the Cliffs of Moher Visitor Centre.		
Comment: Straight on waymarking arrows needed here for Cliffs of Moher Coastal Walk and Burren Way at stile

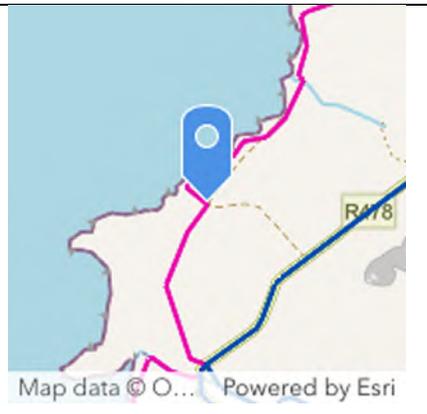
24-7-061		
Severity		
Significant		
Category		
Waymarking Issue		
Issue		
Not Clearly Visible on Approach		
Coordinates*	52.98614, -9.42219	
Location: North of the Cliffs of Moher Visitor Centre.		
Comment: Left and right turn waymarking arrows needed at stile.

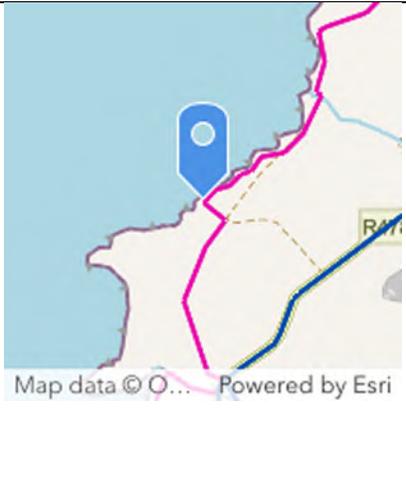
24-7-062		
Severity		
Safety		
Category		
Signage Issue		
Issue		
Hazard without Warning Signs e.g. Dangerous cliffs, mines or tidal areas		
Coordinates*		
52.98678, -9.42349

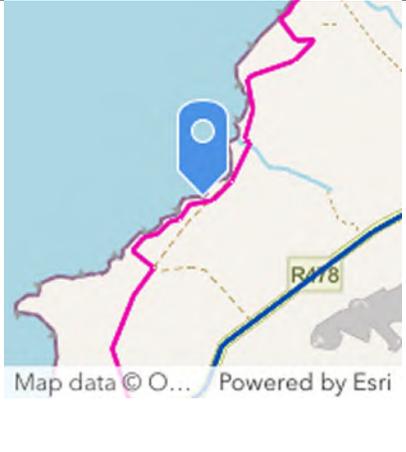
24-7-063		
Severity		
Safety		
Category		
Structures Issue		
Issue		
Footbridge: Damaged, Rotting, Loose		
Coordinates*		
52.98860, -9.41922

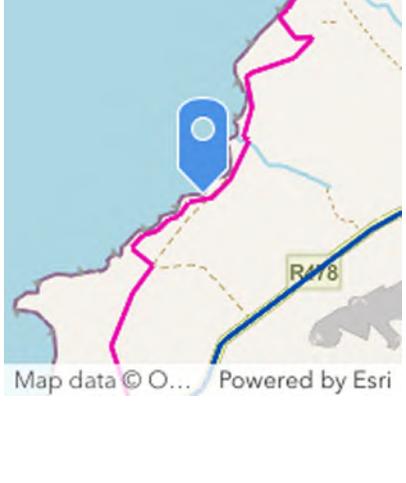
24-7-064		
Severity		
Safety		
Category		
Signage Issue		
Issue		
Hazard without Warning Signs e.g. Dangerous cliffs, mines or tidal areas		
Coordinates*		
52.98859, -9.41916

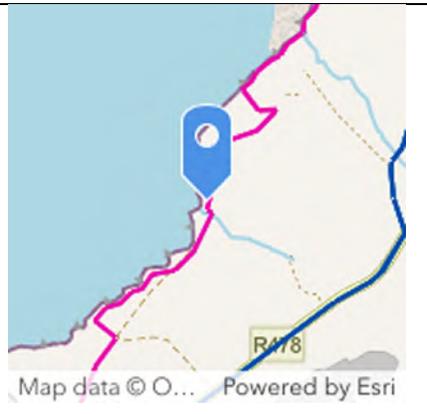
24-7-069		
Severity		
Significant		
Category		
Fencing Issue		
Issue		
Other		
Coordinates*		
52.99094, -9.41673		
Location: North of the Cliffs of Moher Visitor Centre.		
Comment: Broken fence is falling into the trail and needs to be replaced.

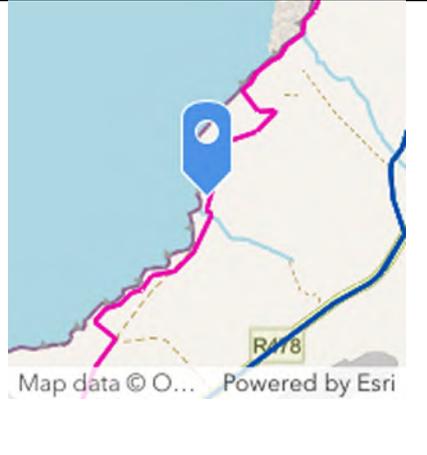
Severity	Significant		
Category	Structures Issue		
Issue	Steps: Damaged, Rotting, Loose		
Coordinates*	52.99112, -9.41671		
Location: North of the Cliffs of Moher Visitor Centre.			
Comment: Top stone in steps down to bridge needs to be replaced.

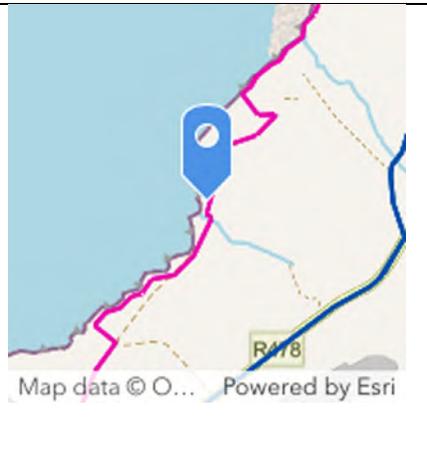
Severity	Safety		
Category	Signage Issue		
Issue	Hazard without Warning Signs e.g. Dangerous cliffs, mines or tidal areas		
Coordinates*	52.99112, -9.41671		
Location: North of the Cliffs of Moher Visitor Centre.			
Comment: Unofficial path leading off the official trail towards the cliff edge needs warning signage and advice to walkers to stay on the official trail.

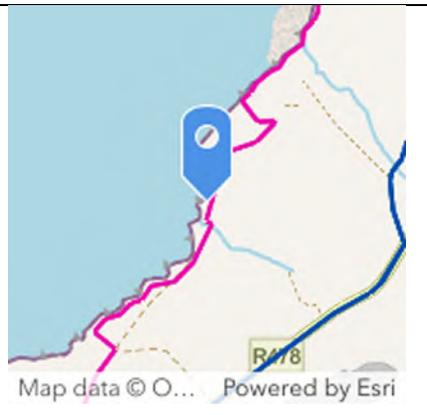
Severity	Significant		
Category	Waymarking Issue		
Issue	Missing/Needed		
Coordinates*	52.99132, -9.41669		
Location: North of the Cliffs of Moher Visitor Centre.			
Comment: Straight on arrows needed in both directions as stile is not part of the way marked way.

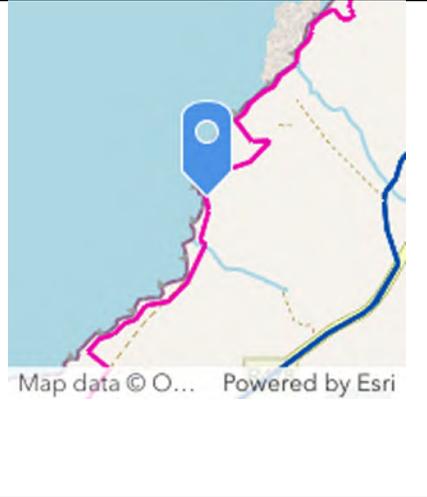
Severity	Safety		
Category	Signage Issue		
Issue	Hazard without Warning Signs e.g. Dangerous cliffs, mines or tidal areas		
Coordinates*	52.99220, -9.41633		
Location: North of the Cliffs of Moher Visitor Centre.			
Comment: Signage needed to warn walkers not to leave the official trail.

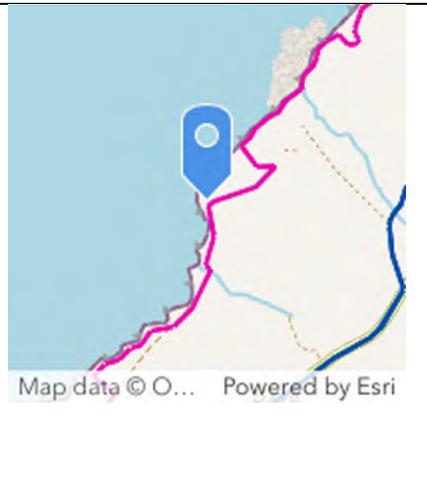
Severity	Safety		
Category	Signage Issue		
Issue	Hazard without Warning Signs e.g. Dangerous cliffs, mines or tidal areas		
Coordinates*	52.99298, -9.41665		
Location: North of the Cliffs of Moher Visitor Centre.			
Comment: Signage needed to warn walkers not to leave the official trail.

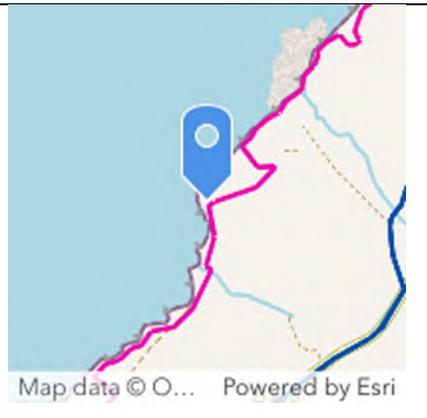
Severity	Safety		
Category	Structures Issue		
Issue	Fence: Missing/Needed		
Coordinates*	52.99297, -9.41668		
Location: North of the Cliffs of Moher Visitor Centre.			
Comment: Crash barrier/fence needed where walkers come down a sloping section of the trail and out onto the cliff edge.

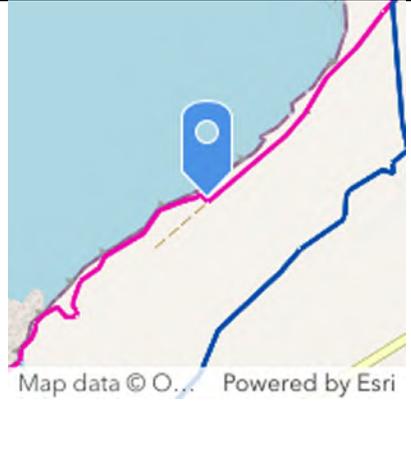
24-7-083		
Severity		
Significant		
Category		
Structures Issue		
Issue	<p>Fence: Damaged, Rotting, Loose</p>	
Coordinates*		
53.00288, -9.39983		
Location: North of the Cliffs of Moher Visitor Centre.		
Comment: Fencing broken needs to be fixed.

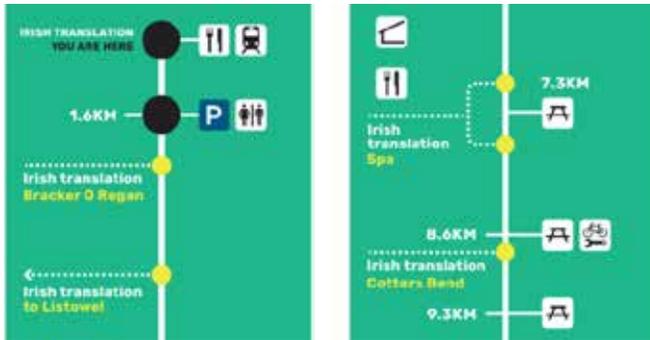
Clear Mapping

Currently, there is a miscommunication between the information that is online and maps on site. For the mapping to be effective, the information provided needs to be consistent. At the minute there are several maps that can be found online and are too detailed for a single linear footpath, showing more information than necessary.

The suggestion would be to redesign a map in the correct brand styling so that it can be used through out the official website and on the ground at access points and visitor centre.

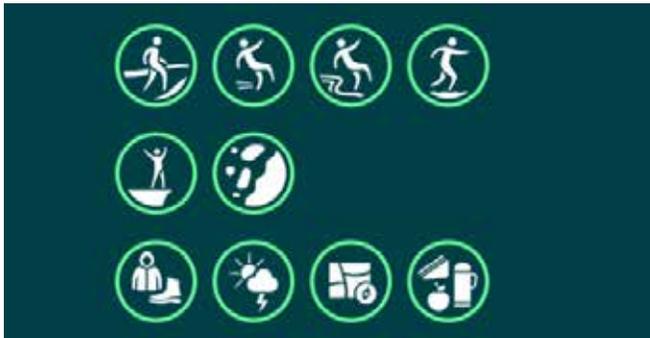
Internationally recognised icons

Using internationally recognised symbols on signage provides quick recognition and improved safety by being clear, accessible and understood by international visitors. There should be icons to also distinguish the grading of the Coastal Walk so visitors know what to expect if they do use the footpaths.

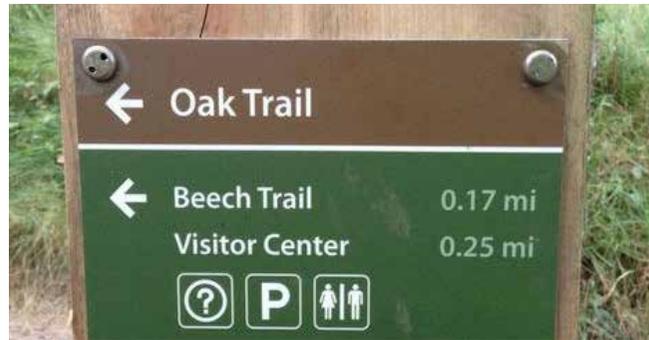
Wayfinding & Distance Location

As mentioned previously and highlighted in the Sport Ireland Walking Trail Inspection Report, there is currently a lack way markers and distance markers in prominent locations.

We would recommend this is introduced and upgraded in the same branded way. The colour coded system that the emergency services have recommended should be introduced into the signage at intervals along the route and also within the mapping so that visitors are constantly and consistently aware of this system.

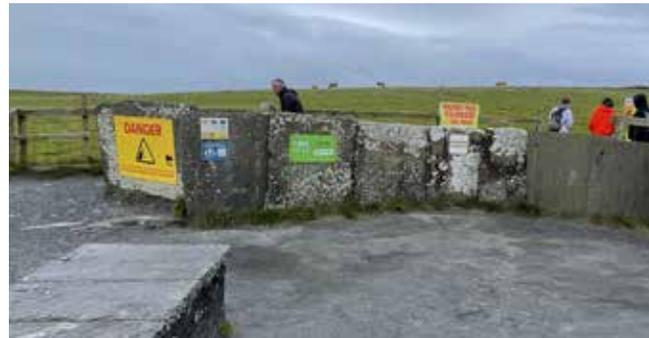
De-clutter

Clear and unambiguous information at relevant locations should be displayed to avoid giving too much information and creating visual clutter which will confuse the user, impair legibility and can create a state of overwhelming information or 'information overload'.

When too many signs compete for attention, it can lead to confusion and misinterpretation, as users may struggle to discern which signs are most important. The impact of each individual sign is reduced, and important messages may be overlooked.

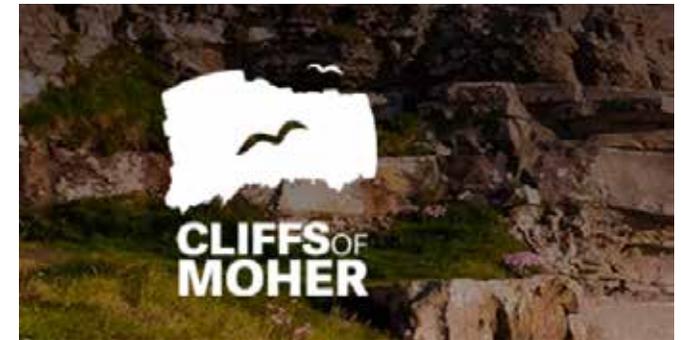
Consistent Branding

Consistency in the branding of signage ensures that all information is conveyed in a uniform way, making it easier for users to understand directions, warnings, and other important details. When signage follows a standard format, it reduces confusion and misinterpretation, ensuring that everyone receives the same message. Additionally, it reinforces the identity of the walk.

It also ensures emergency protocols and warnings are immediately recognisable. This can expedite emergency response times, as both users and responders are more likely to understand and follow the instructions provided.

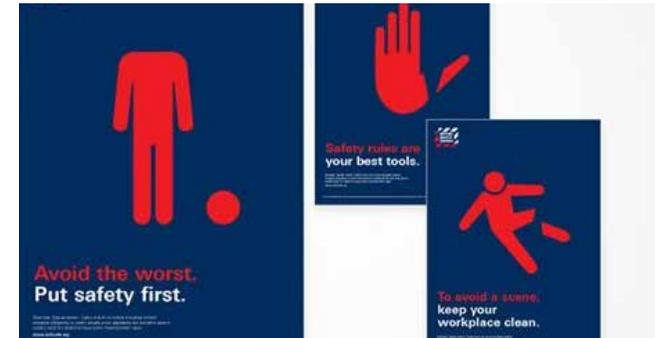
More prominent safety signage

To increase the prominence and effectiveness of the walk's safety signage there should be clear, bold icons and high-contrast colours to ensure signs are easily noticed, Sport Ireland have suggested red text and icons. Currently a lot of the safety signage and messaging is low and not at eye level, we would suggest that the warnings are large, readable, and positioned at eye level, possibly incorporating reflective materials for visibility in low light.

There should also be an element that highlights the colour coding as described earlier to aid emergency services and reinforce the system while visitors are walking.

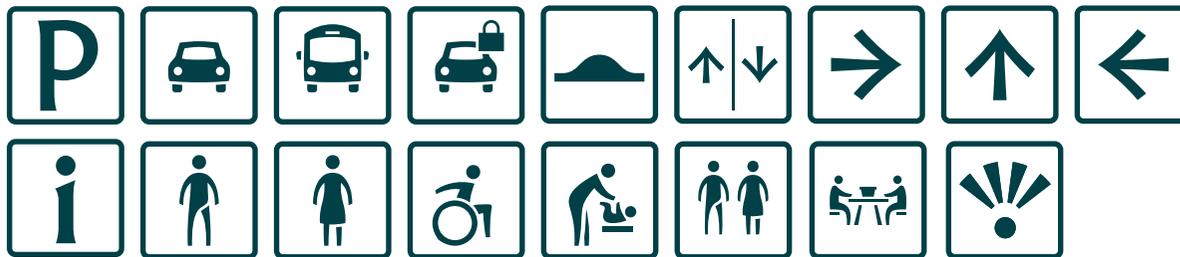
INFORMATION & FACILITIES

Using internationally recognised symbols on signage provides quick recognition and improved safety by being clear, accessible and understood by international visitors. Below are a set of icons form the National Parks wayfinding toolkit, we suggest that a full set of icons are developed for the Cliffs of Moher of the range shown below.

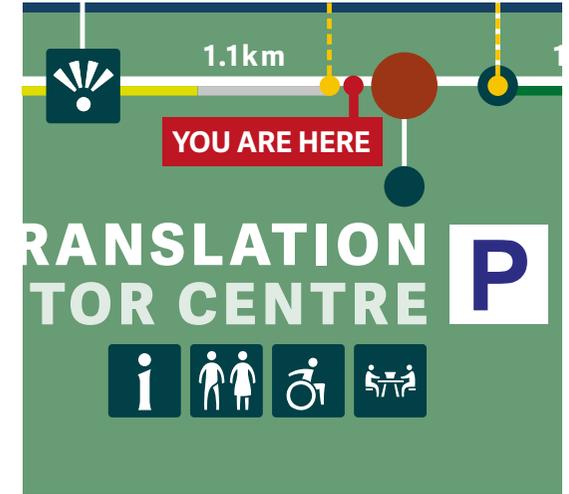
'You are here' Point

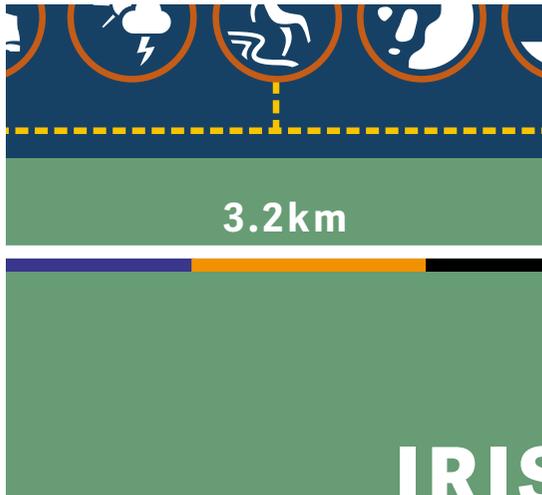
Cautionary and Informational Universal Icons

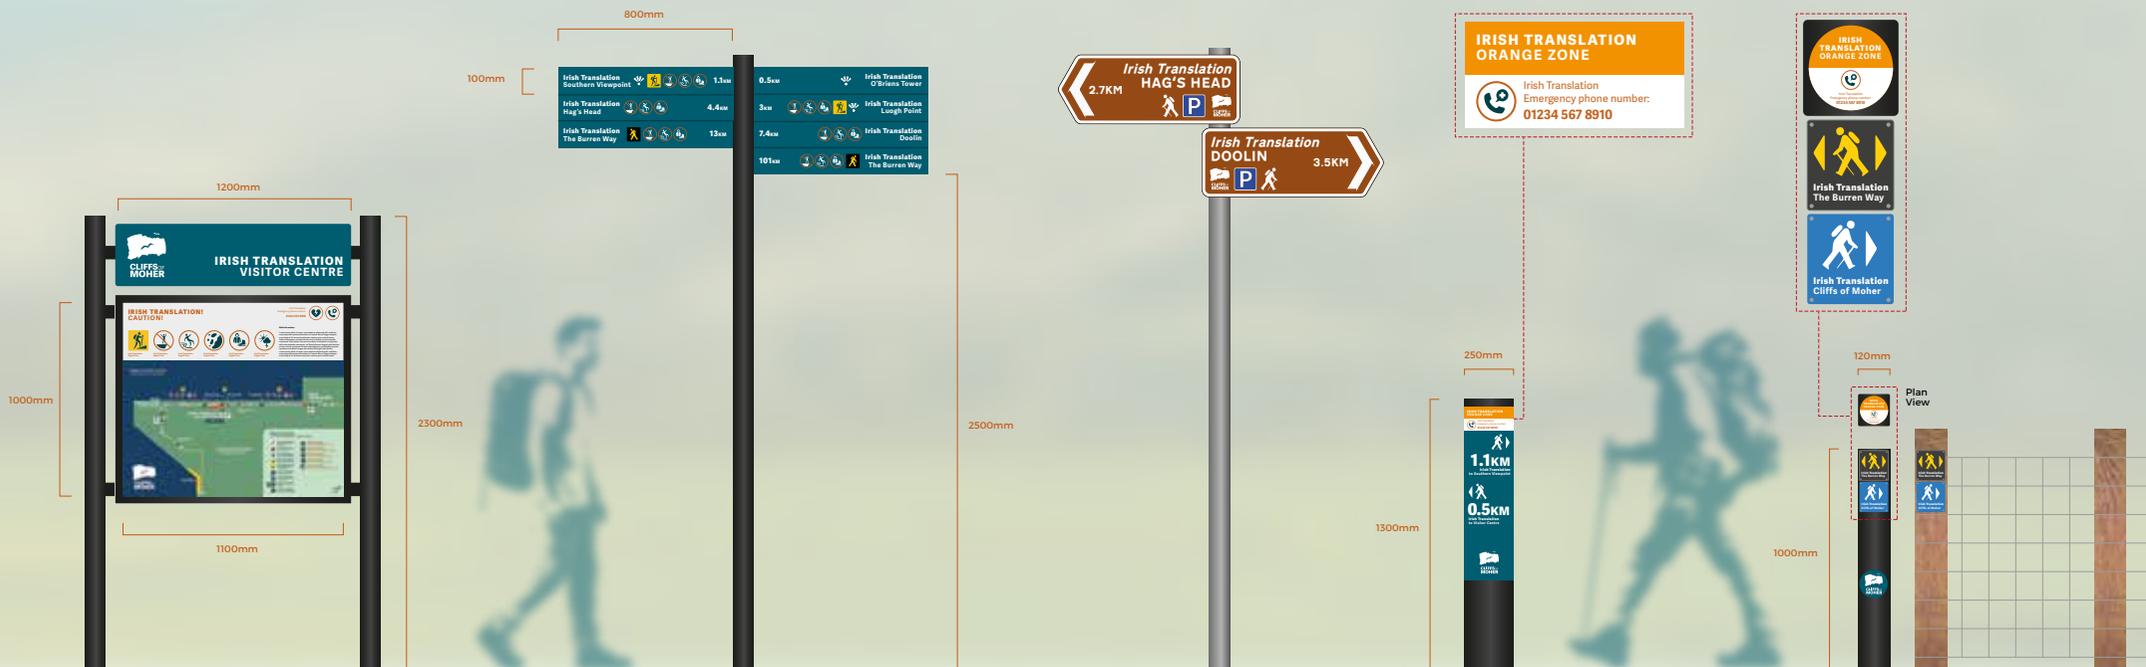
Sign Type: **Visitor Map and Caution Sign**
Code: **ST01**

As part of the wayfinding plan, we have set out a co-ordinated sign family which uses the same branding and visual language throughout the visitor journey.

Powdercoated map panel and cautionary informations, to be located at all key entry points to the walk and in prominent locations. Should display all safety and emergency information.

Recycled plastic posts with hard-wearing panel & full colour printed graphics. To show distance to next destination and display emergency contact information.
